2021 Concrete Sidewalk Condition Assessment Report

PRESENTED TO
City of Camrose

NOVEMBER 19, 2021
ISSUED FOR USE
FILE: 704-TRN.ASMT03049-01

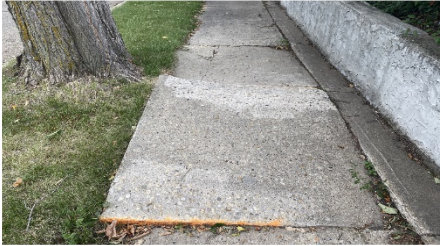
Faulting Hazard due to roots

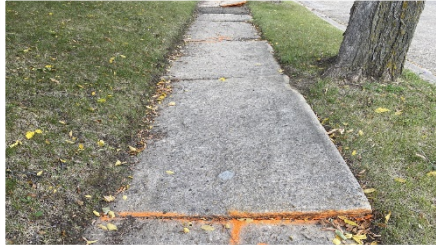
Faulting Hazard due to roots

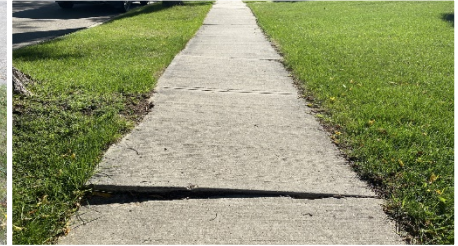
Faulting Hazard due to roots

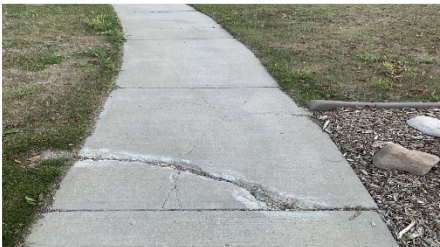
Cracking

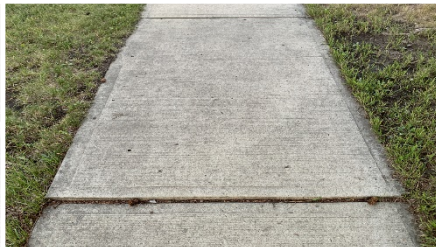
Faulting

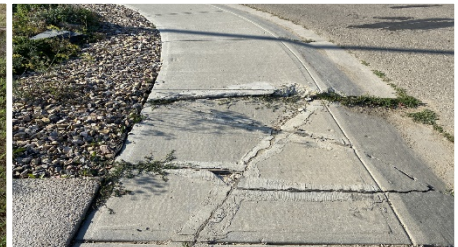
Settlement

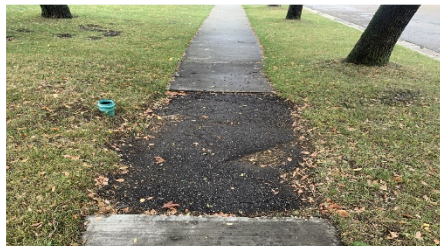
Utility Cuts

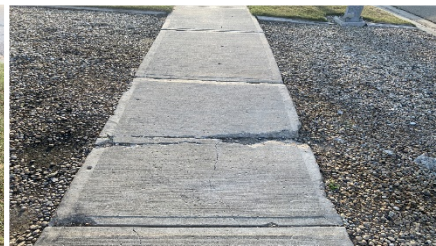
Spalling

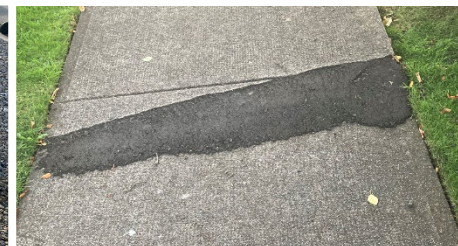
Fillets

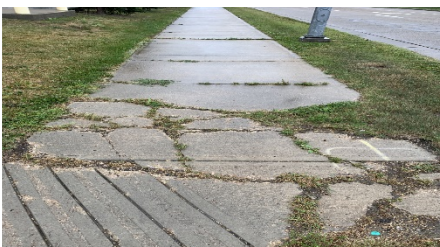
Vegetation

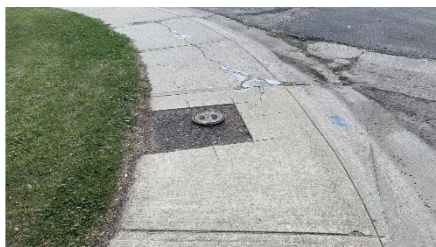
Obstruction

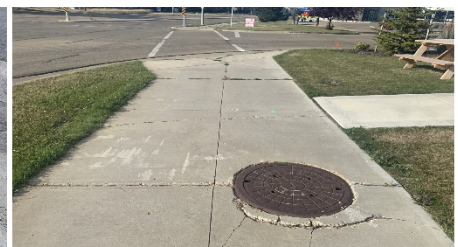
Other (manhole, etc.)
