# Trails Condition Assessment Report

PRESENTED TO  
**City of Camrose**

DECEMBER 18, 2019  
ISSUED FOR USE  
FILE: 704-TRN.PAVE03186-01

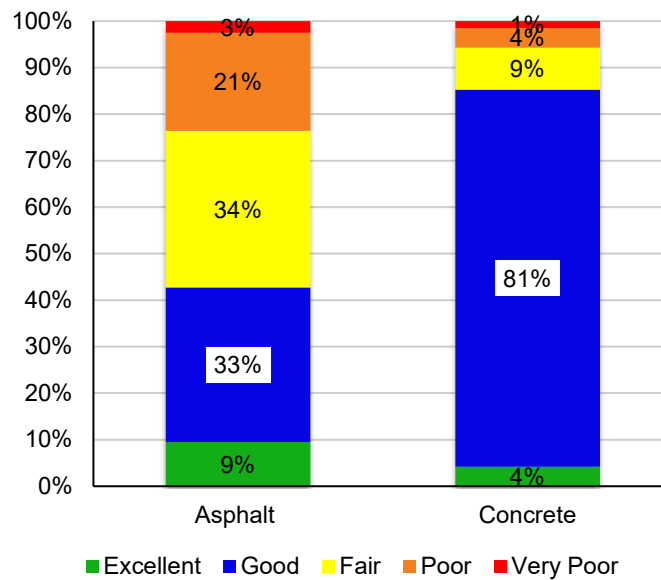
**Figure 5-1: 2019 Trail Condition of Collected Trails**

Figure 5-1 shows that about a quarter of the asphalt trail is in very poor to poor condition while three quarters are in fair to excellent condition. Approximately 9% of the asphalt trail network is in new condition.

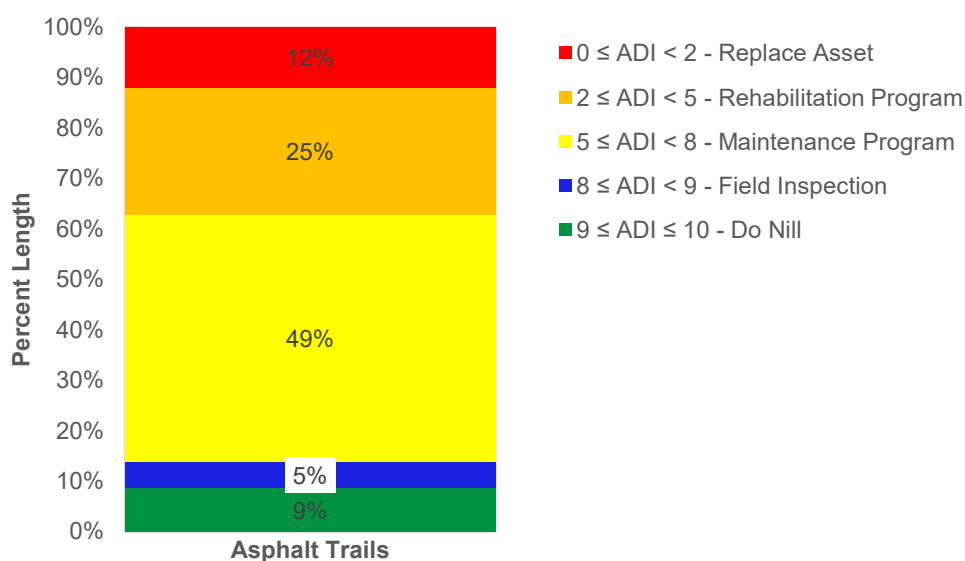
**Figure 6-1: Priority Activity Plan for Asphalt Trails**

Figure 6-1 shows that approximately 12% of the paved trail assets need to be replaced. Similarly, a quarter of the asphalt trail assets are triggered for the development of a rehabilitation program. Approximately half of the paved trail assets are triggered for development of a maintenance program. Approximately 5% of the assets are triggered for field inspection. Remaining 9% of the asphalt trail assets are in good condition and do not require any activity.

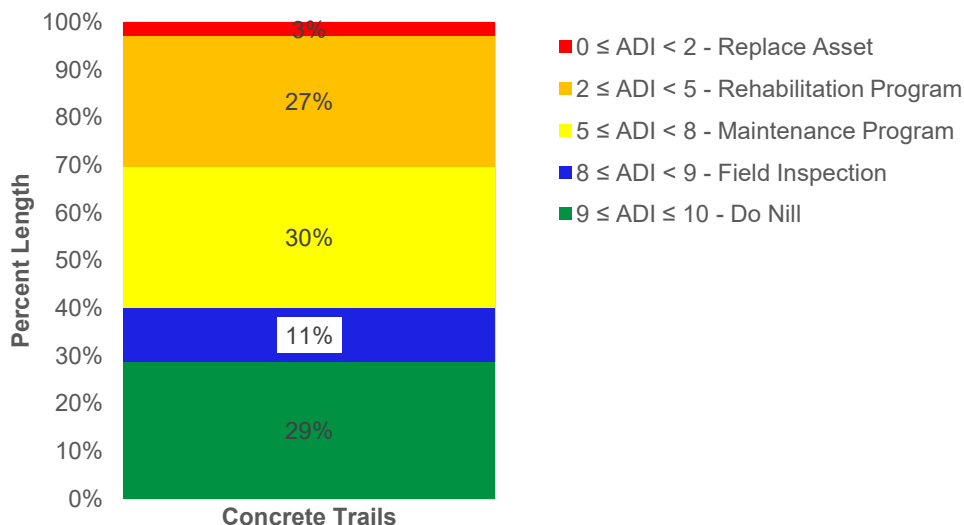
**Figure 6-2: Priority Activity Plan for Concrete Trails**

Figure 6-2 shows that approximately 3% of the collected concrete trail assets need to be replaced. Similarly, more than a quarter of the collected concrete trail assets are triggered for the development of a rehabilitation program. Approximately one-third of the collected concrete trail assets are triggered for development of a maintenance program. Approximately 11% of the assets are triggered for field inspection. The remaining quarter of the collected concrete trail assets are in good condition and do not require any activity.
