City of Camrose

Heritage Survey and Inventory

City of Camrose Heritage Survey and Inventory Final Report

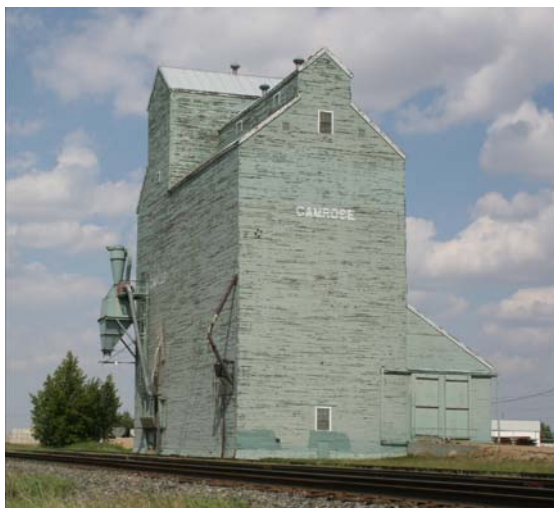
4816 41 Street**Alberta Wheat Pool No. 2 Grain Elevator**

This 1965 Alberta Wheat Pool No. 2 grain elevator has an intersecting monitor roof and green clapboard siding with "CAMROSE" and "No. 2" painted in white along the side. The grain elevator is located on the railway tracks in a highway commercial area in the City of Camrose.

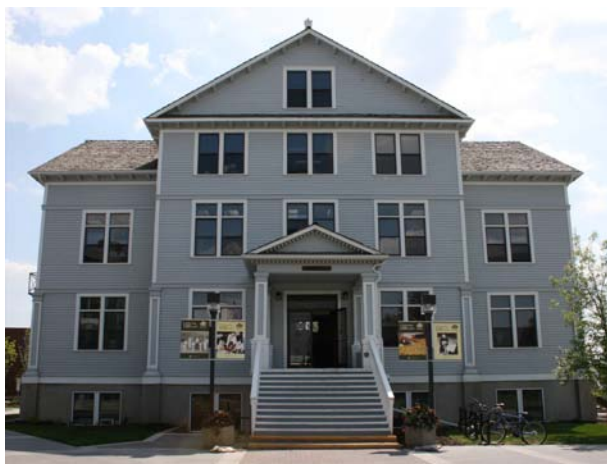
4901 46 Avenue**“Old Main” Camrose Lutheran College**

This 1911 three and one half storey symmetrical façade structure has a large frontispiece with pediment and has clapboard siding. “Old Main”, as it is known, has an open front porch with a pediment gable roof. It is located on the University of Alberta, Augustana Campus in the City of Camrose.

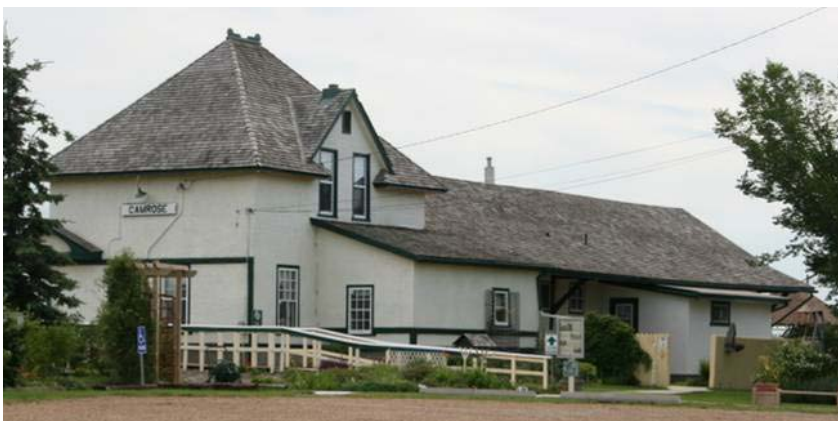
4407 47 Avenue**Canadian Northern Railway Station**

This 1911 one and one half storey Canadian Northern Railway (CNoR) Station is a “Third Class” station constructed according to the Canadian Northern Railway Plan 100-29 and features a hip roof, gable dormers, stucco exterior, a substantial baggage area extension, and wide eaves with large brackets extending along the trackside elevation. The site also includes a 1919 section tool shed and 1918 watchmen’s shed. The two sheds are simple wood frame structures with red exterior walls and yellow trim. All three buildings are situated on approximately ten hectares of land in the east end of the City of Camrose along the railroad tracks.

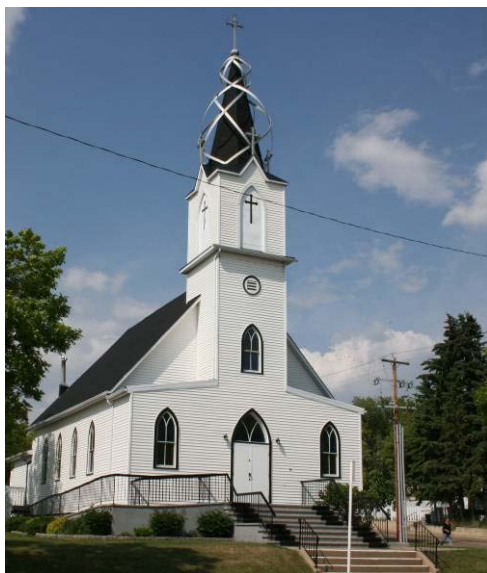
5304 48 A Avenue**Ukrainian Catholic Church**

This 1910 Ukrainian Catholic Church has a front facing gable roof with a large intersecting tri level tower with steeple. It has clapboard siding and pointed arch windows and a pointed arch entrance. The steeple is decorated with two additional metal crosses and spiral. It is located on the north side of Mirror Lake in the City of Camrose.

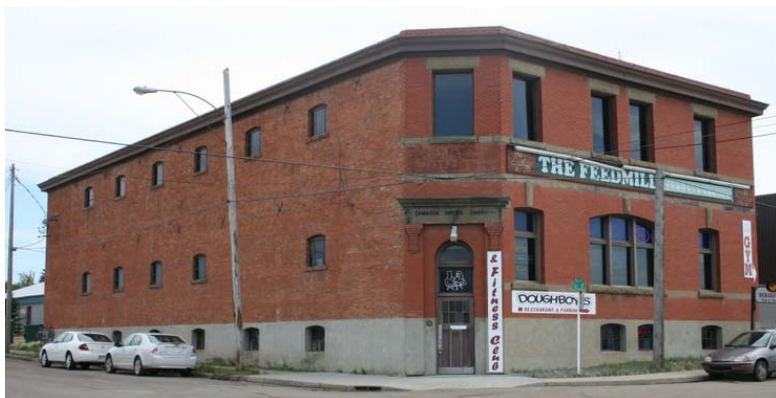
4919 47 Street**Camrose Feed Mill**

The 1910 two storey Camrose Feed Mill has a red brick exterior, chamfered front corner entryway, and arched windows. It is located on a corner lot in a commercial area in the City of Camrose.

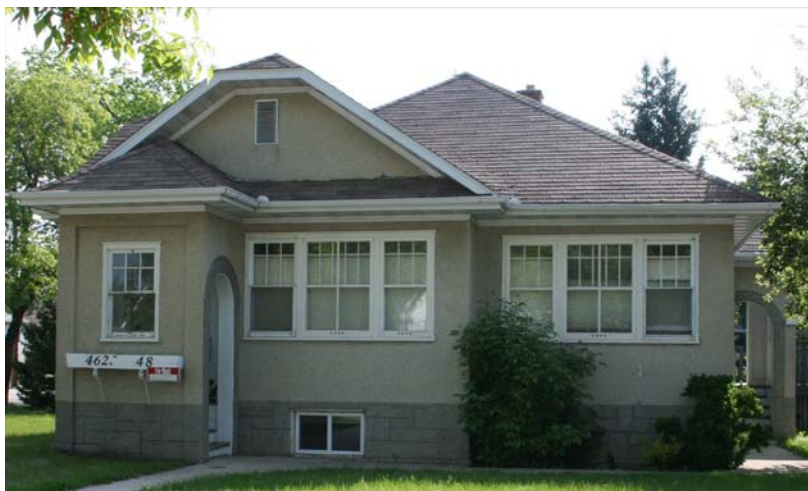
4623 48 Street**Residence**

This 1929 one storey residence has a hip roof and a front-facing hipped gable dormer with stucco exterior and an enclosed front porch with a half pyramid roof. It is located on a single corner lot in a residential neighbourhood in the City of Camrose.

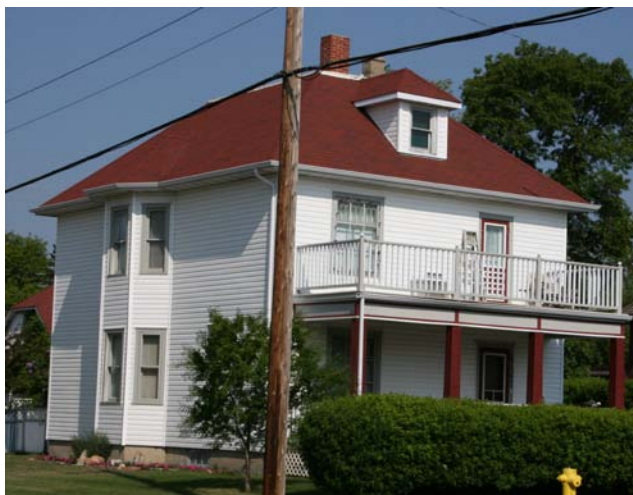
4702 48 Street**Residence**

This 1910 two and one half storey residence has a truncated pyramid roof and a front-facing hip dormer with a full length open front porch with a balcony above. It is located on a single corner lot in a residential neighbourhood in the City of Camrose.

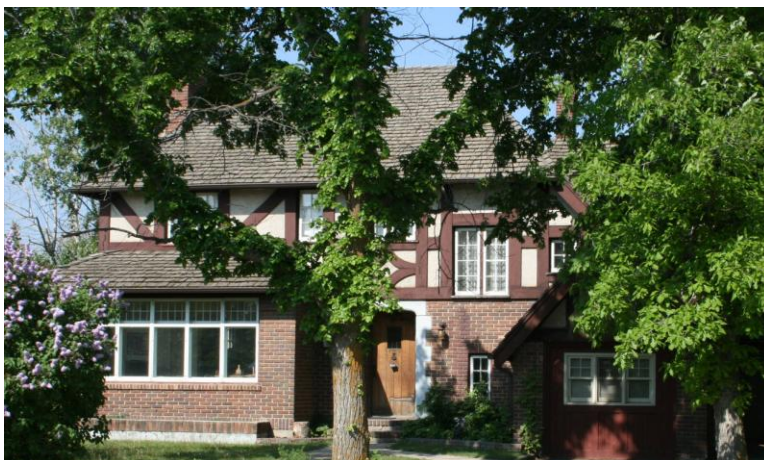
4706 48 Street**Residence**

This 1929 two storey residence has a wood shingle hip roof with a side intersecting gable, and a brick first storey with half timbering along the second storey. It is located on a single lot in a residential neighbourhood in the City of Camrose.

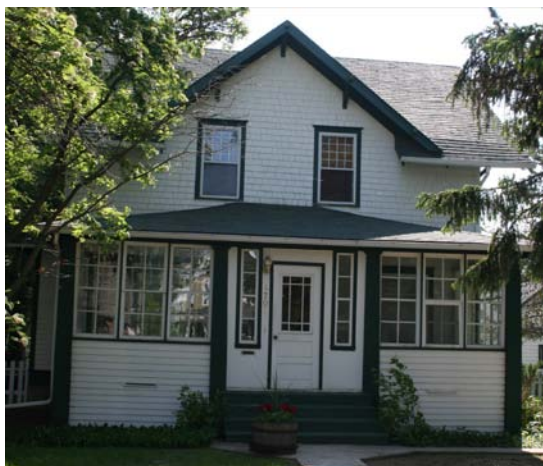
4707 48 Street**Residence**

This 1920 two storey residence has side-facing main gable with an intersecting front-facing center gable with return eaves and has an enclosed front porch. It is located on a single lot in a residential neighbourhood in the City of Camrose.

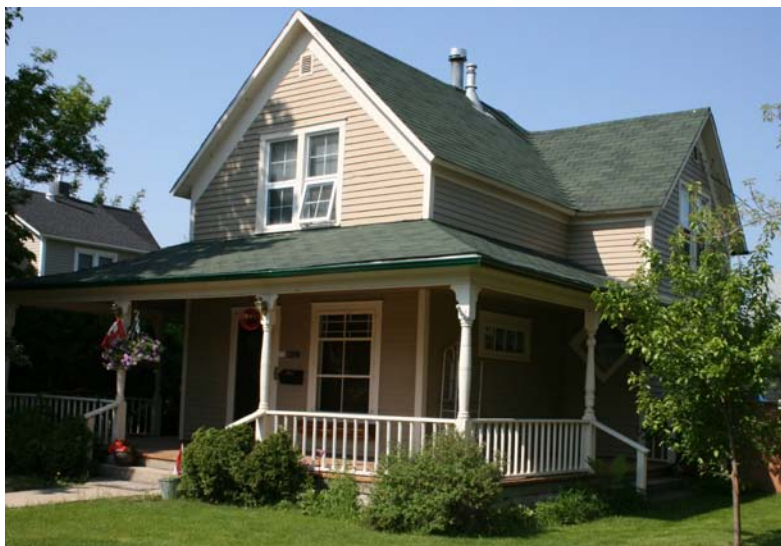
4720 48 Street**Residence**

This 1906 two storey L shaped plan residence has a front and side-facing gable roof with clapboard siding and a wraparound front veranda. It is located on a single lot in a residential neighbourhood in the City of Camrose.

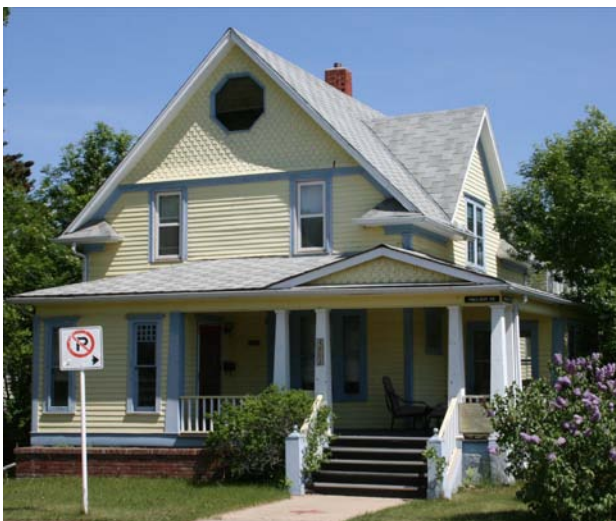
4803 48 Street**Residence**

This 1919 two and one half storey residence has a large octagon window in the front-facing gable roof and returned eaves. The residence has clapboard siding with fishscale shingles under the gable and an open porch. It is located on a single corner lot in a residential neighbourhood in the City of Camrose.

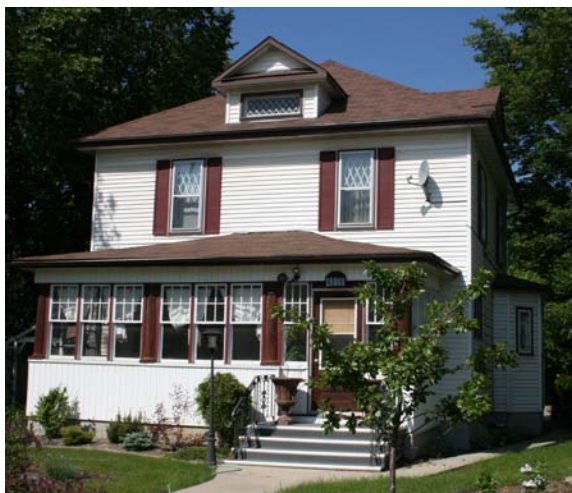
4806 48 Street**Residence**

This 1912 two and one half storey residence has a hip roof with a front-facing pediment dormer. The residence has an enclosed front porch and stained glass windows. It is located on a single lot in a residential neighbourhood in the City of Camrose.

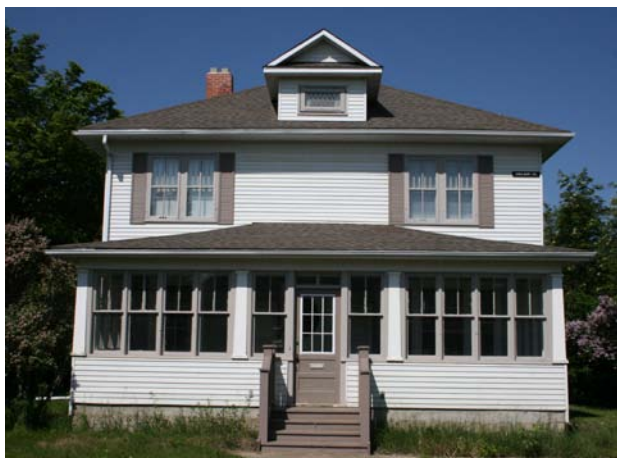
4810 48 Street**Irving and Signe Hills Residence**

This 1910 two and one half storey residence has a hip roof with a front-facing pediment dormer and an enclosed front porch. It is located on a single corner lot in a residential neighbourhood in the City of Camrose.

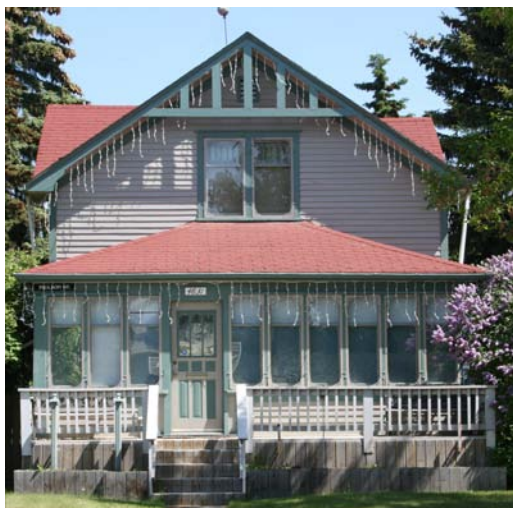
4831 48 Street**Residence**

This 1918 two storey residence has wood clapboard siding and a large front-facing medium pitch gable roof with an intersecting gable roof. The residence has an enclosed front porch. It is located on a single corner lot in a residential neighbourhood in the City of Camrose.

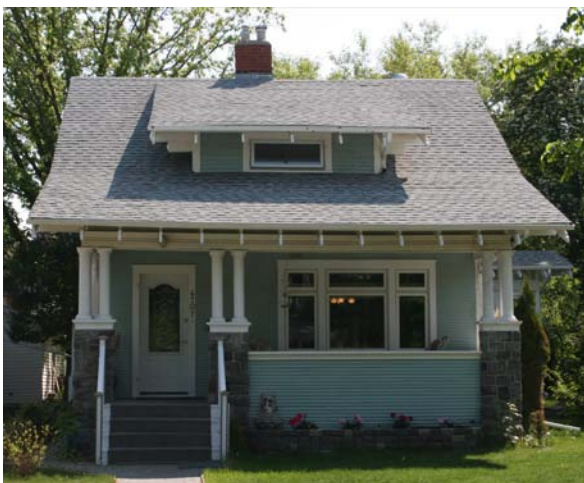
4707 49 Street**Freeman Residence**

This 1919 one and one half storey residence has a side-facing gable roof with flared eaves, and a front-facing shed dormer. The residence has an open front porch with paired Doric columns. It is located on a single lot in a residential neighbourhood in the City of Camrose.

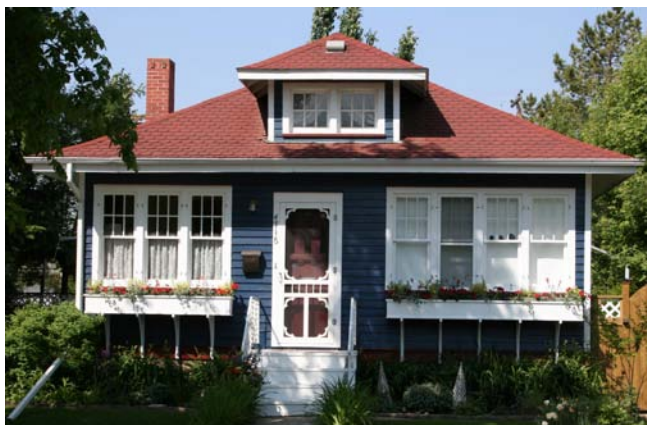
4716 49 Street**Residence**

This 1933 one and one half storey residence has clapboard siding and a hip roof with a front-facing hip roof dormer. It is located on a single lot in a residential neighbourhood in the City of Camrose.

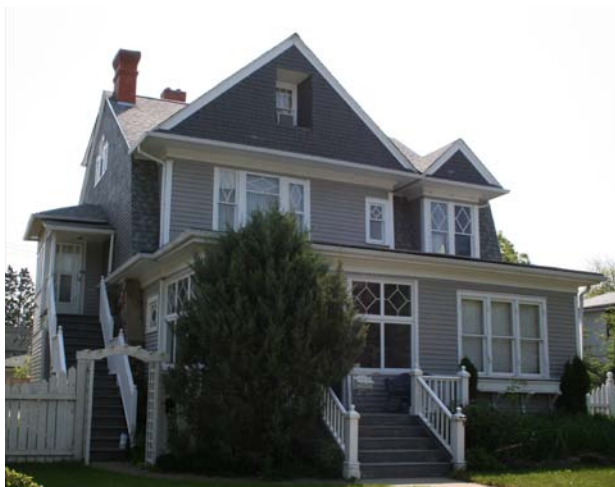
4717 49 Street**G.P. Smith Residence**

The 1915 two and one half storey residence has a side-facing gambrel roof with an intersection pediment gable and a pediment dormer. It has clapboard siding, an enclosed front porch and a number of diamond patterned windows. It is located on a single lot in a residential neighbourhood in the City of Camrose.

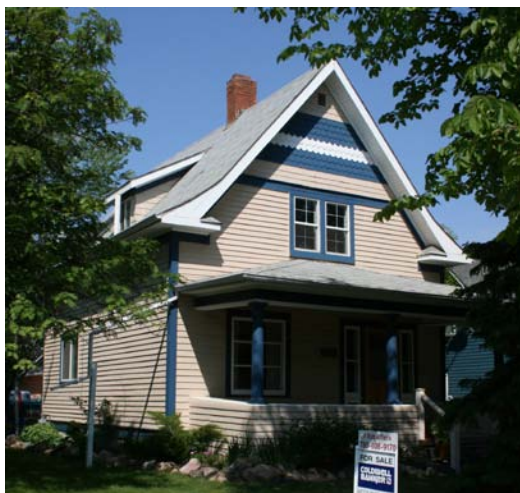
4720 49 Street**Residence**

This 1919 two storey residence has a front-facing gable roof with flared and returned eaves. The residence has an open front porch, clapboard siding and fishscale shingles in the gable end. It is located on a single lot in a residential neighbourhood in the City of Camrose.

- The high pitched front-facing gable roof
- The side shed dormer and side gable dormer
- The oxeye window
- The decorative fishscale shingles in the gable end
- The flared and returned eaves
- The open front porch with solid rail supporting Doric columns round columns
- The central brick chimney
- All authentic windows and doors, and all authentic window and door openings

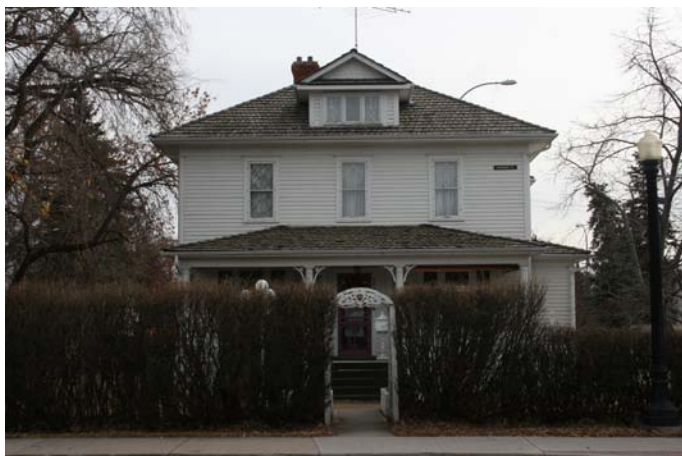
4801 49 Street**Dr. Nordbye Residence**

This 1914 two and one half storey residence has a truncated pyramid roof with wood shingles, front and rear-facing gable dormers, and clapboard siding. It has an open front porch and diamond patterned windows. It is located on a single corner lot in a residential neighbourhood in the City of Camrose.

- The truncated pyramid roof with wood shingles
- The side bays
- The clapboard siding with corner boards
- The front and rear-facing gable dormers
- The open front porch with Doric columns
- The diamond patterned windows
- The one-over-one double hung windows
- All authentic windows and doors, and all authentic window and door openings

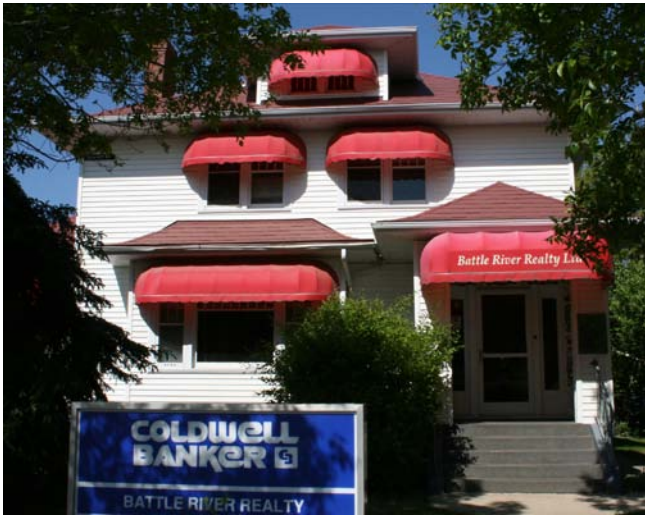
4802 49 Street**Harold Manning Residence**

The 1928 two and one half storey residence has a pyramid roof with flared eaves with front and rear-facing hip dormers. It is located on a single corner lot in a residential neighbourhood in the City of Camrose.

- The pyramid roof with flared eaves and front and rear-facing hip roof dormers
- The enclosed front porch with hip roof and flared eaves
- The two three-over-one windows and the one nine-over-one window on the first storey
- The four four-over-one windows on the second storey
- The plain, flat wood window surrounds around all windows
- The front-facing dormer with two windows
- The brick chimneys
- The wood door located on the second storey of the rear façade
- The side bay with hip roof
- All authentic windows and doors, and all authentic window and door openings

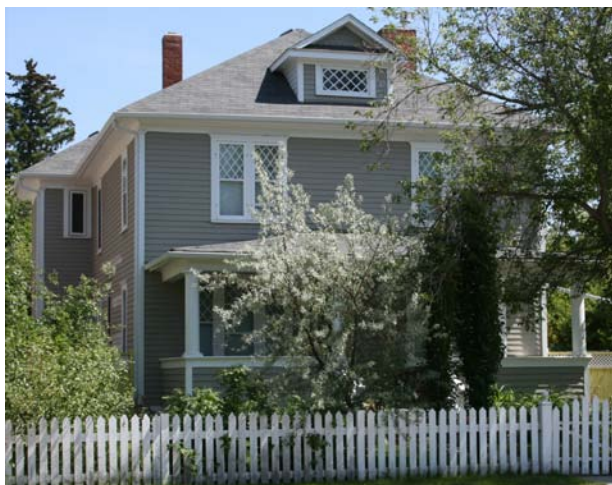
4813 49 Street**Dr. P.F. Smith Residence**

This 1911 two and one half storey hip roof residence has a front-facing pediment dormer, clapboard siding and an open front porch. It is located on a single corner lot in a residential neighbourhood in the City of Camrose.

- The hip roof
- The clapboard siding
- The open front porch and decorative columns
- All authentic windows and doors, and all authentic window and door openings

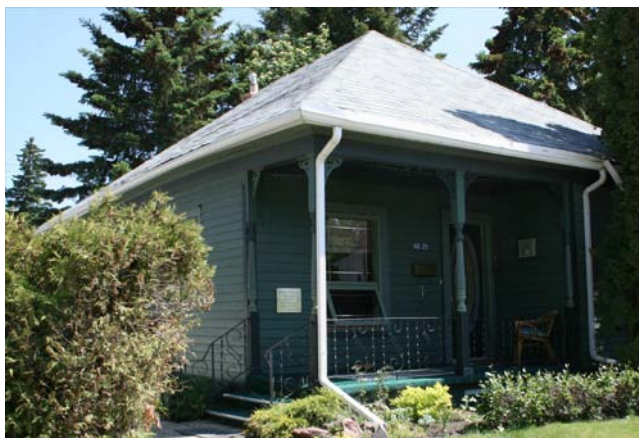
4825 49 Street**Residence**

The 1907 one storey residence has a hip roof with clapboard siding and an open front porch. It is located on a single lot in a residential neighbourhood in the City of Camrose.

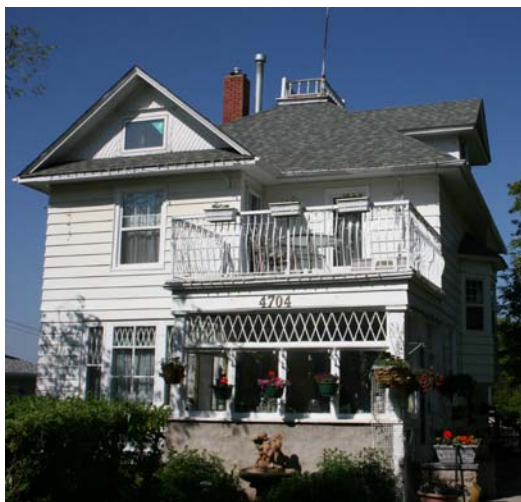
4704 50 Street**C.G. Corneille Residence**

This 1907 two and one half storey residence has a truncated pyramid roof with a front-facing pediment dormer, a side-facing gable dormer, a widow's walk, and clapboard siding. It is located on a single lot in a residential neighbourhood in the City of Camrose.

- The truncated pyramid roof with a widow's walk
- The front-facing pediment dormer and side-facing gable dormer
- The open front porch with square columns and flat roof with balcony above
- The three-by-three windows and one-over-one windows on the first storey
- The nine-over-one window on the second storey
- The side nine-over-one window on the first storey
- All authentic windows and doors, and all authentic window and door openings

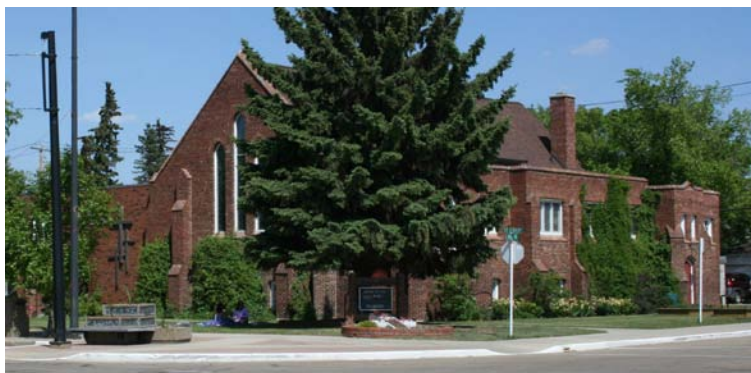
4829 50 Street**Camrose United Church**

The 1926 Camrose United Church has a brick exterior, the roof of the nave is a high pitched front-facing gable roof, and tall pointed arched windows on the front façade. It is located on a corner lot on the main street in the City of Camrose.

- The brick faux stepped buttresses
- The front and rear arched windows and window openings
- The arched stained glass windows along the side façade
- The rectangular stained glass windows along the side façades
- The two-over-two windows along the basement
- The rear glass block windows
- All authentic windows and doors, and authentic window and door openings

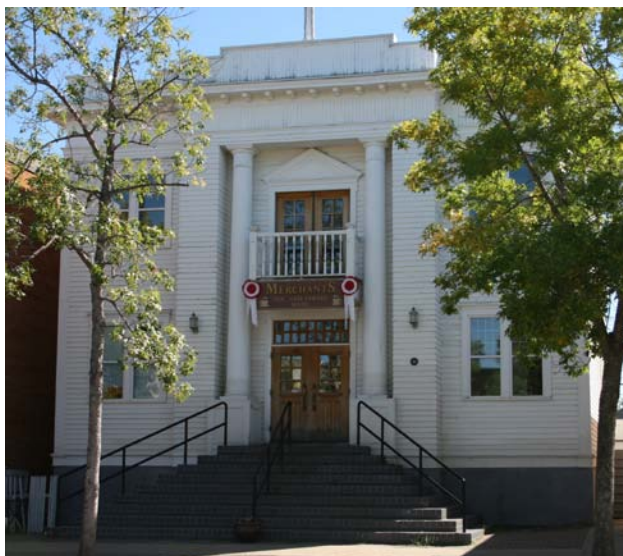
4857 50 Street**Camrose Public Library**

The 1908 two storey Camrose Public Library has white clapboard siding and a classically inspired front entrance with two storey Doric columns on either side of the front doors, a large cornice with dentils, and a second storey balcony with a pediment doorway. It is located on main street in the City of Camrose.

- The flat roof with stepped parapet
- The eaves with bracket supports
- The clapboard siding on first and second storeys and vertical siding above fascia and on parapet
- The columns around front entrance
- The second storey balcony and pediment doorway
- The fenestration pattern
- The double door entryway

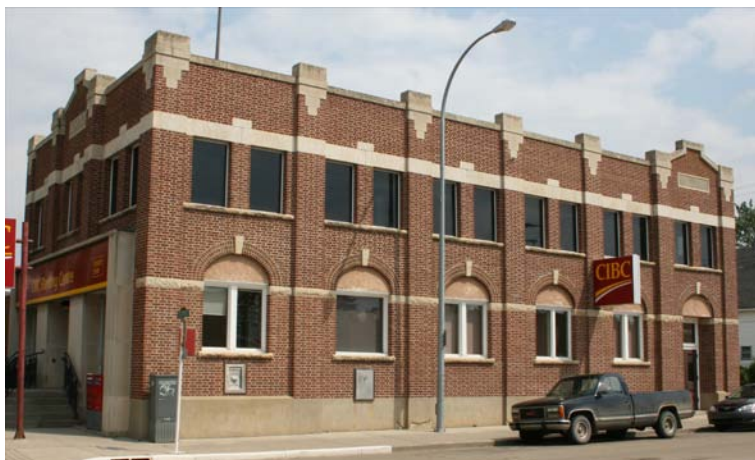
4901 50 Street**Camrose Federal Building**

This 1932 two storey brick commercial building has three symmetrical bays on the front façade and six bays on the side façades which are defined by brick pilasters capped with cast stone capitals. The building has first storey arched window openings with keystones, and decorative cast stone detailing. It is located on a corner lot on main street in the City of Camrose.

- The brick exterior with cast stone detailing at the first and second storeys
- The flat roof with cast stone capped parapet
- The brick pilasters with cast stone capitals
- The “CAMROSE” name stone on the second storey
- The arched two pane windows, cast stone keystone and cast stone sills,
- All authentic windows and doors, and all authentic window and door openings

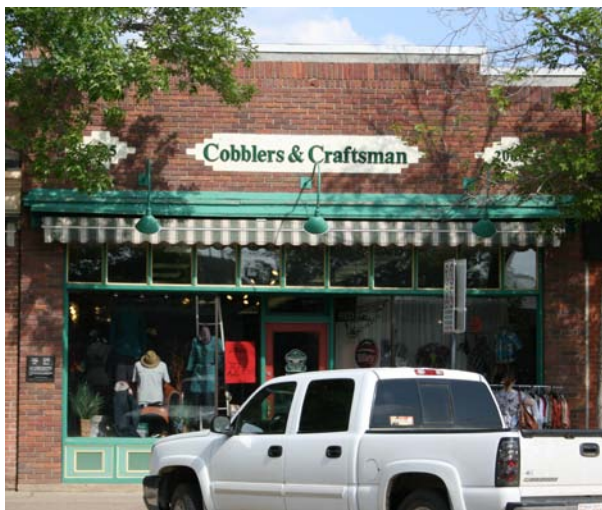
4917 50 Street**Foucar Grocery Store**

This 1924 one storey brick commercial building has a commercial storefront with large display windows with transoms, wood panelled bulkheads and a recessed entrance. It is located on a commercial lot on main street in the City of Camrose.

- The commercial storefront with large display windows with transoms, wood bulkheads, and recessed entrance
- The flat roof
- The brick cladding with recess mortar joints
- The decorative soldier bricks under the parapet
- All authentic windows and doors, and all authentic window and door openings

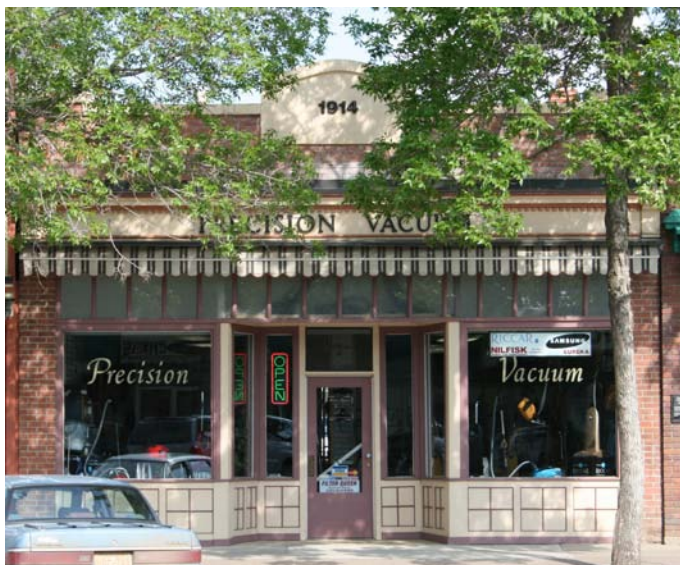
4921 50 Street**Johnstone's Drug Store**

The 1914 Johnstone's Drug Store is a one storey brick building with a retail storefront which has a recessed doorway, plain bulkheads and large display windows with transoms. It is located on a commercial lot on main street in the City of Camrose.

- The commercial storefront including the large display windows with wood build heads, the recessed entrance, the transom windows and the sign board
- The brick exterior
- The flat roof
- The arched date stone that reads “1914”

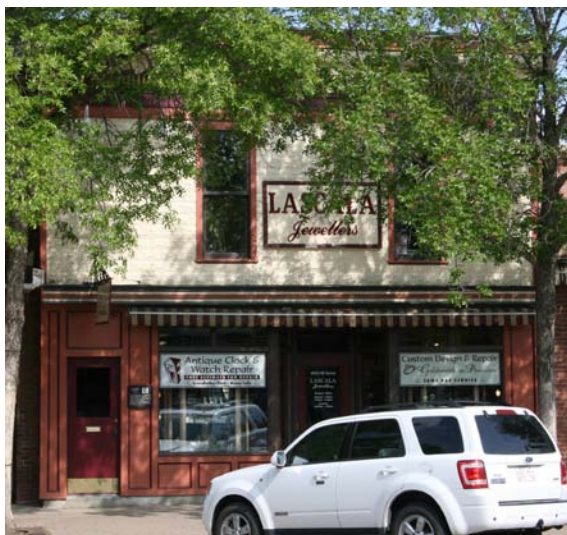
4925 50 Street**Langbell's Studio**

This 1910 two storey commercial building has a wood panelled lower storey and a faux tin concrete block design on the second storey with a recessed doorway and has a first and second story cornice. It is located on a commercial lot on main street in the City of Camrose.

- The two decorative cornices
- The wood panelled lower storey
- The faux tin concrete block design on the second storey
- The recessed doorway
- All authentic windows and doors, and authentic window and door openings

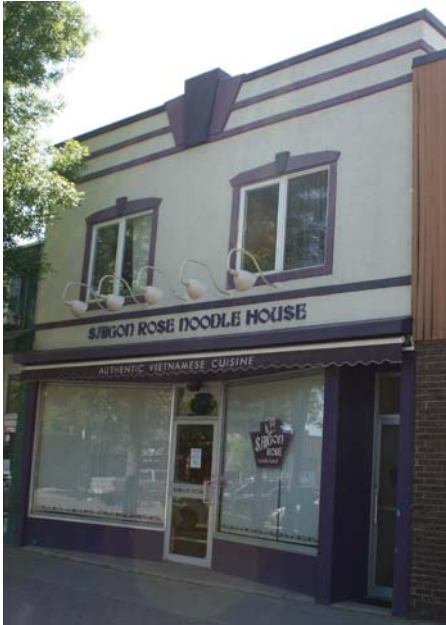
4938 50 Street

This 1935 two storey commercial building has a stucco exterior with a decorative cornice along the top of the second storey and a recessed doorway. It is located on a commercial lot on main street in the City of Camrose.

- The first storey cornice
- The second storey art deco faux quoin cornice with horizontal stripes
- The angular recessed doorway
- The second storey window openings, sills, and lintels
- All authentic windows and doors, and authentic windows and door openings

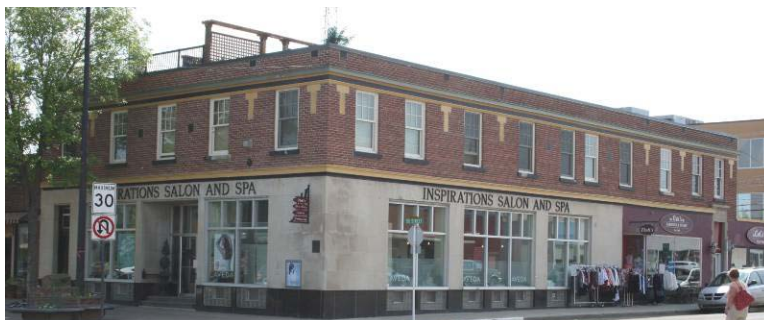
4980 50 Street**Masonic Temple**

The two storey 1928 Masonic Temple has a brick and concrete exterior with a decorative cornice along the top of the second storey and a recessed doorway. There is an inscription above the side door that reads "MASONIC TEMPLE" and glass blocks around the basement windows. It is located on a corner lot on main street in the City of Camrose.

- The stone exterior on the first storey
- The decorative brick work on second storey
- The stone foundation
- The glass blocks around basement windows
- The six-over-one windows on the second storey
- All authentic windows and doors, and window and door openings

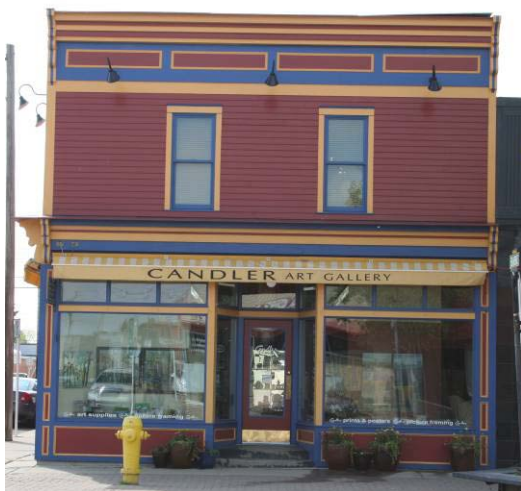
5002 50 Street**Samson Building**

This 1904 two storey commercial building has clapboard siding, large display windows with wood panel bulkheads and transom windows, a recessed doorway, and first and second storey cornices. It is located on a corner lot on main street in the City of Camrose.

- The flat roof
- The clapboard siding with corner boards
- The decorative cornice and brackets along the first storey
- The decorative wood panels along the top of the second storey
- The storefront including the large display windows, the decorative wood panels in the storefront bulkhead, the transom windows and the recessed doorway
- The second storey one-over-one windows
- All authentic windows and doors, and authentic window and door openings

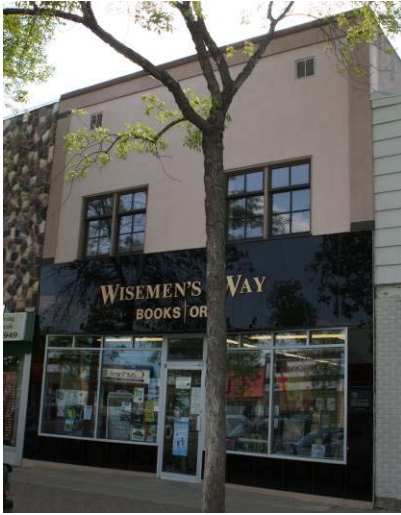
5028 50 Street**Dabbs Furniture**

This 1948 two storey commercial building has a flat roof, stucco exterior on the second storey and black carrack glass panels on the exterior of the first storey. It is located on a commercial lot on main street in the City of Camrose.

- The second storey stucco exterior with pilasters
- The first storey black carrack glass
- All authentic windows and doors, and all authentic window and door openings

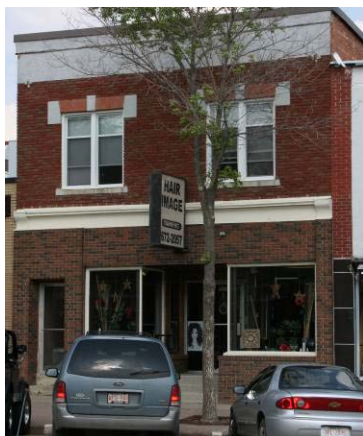
5029 50 Street**Molsons Bank**

The 1908, two storey Molsons Bank brick building has a cornice on the first storey and a recessed entrance. It is located on a single lot in a commercial area on main street in the City of Camrose.

- The running bond brick exterior with recessed mortar joints
- The first storey cornice
- The second storey window brick and cast stone lintels and cast stone sills
- All authentic windows and doors, and all authentic window and door openings

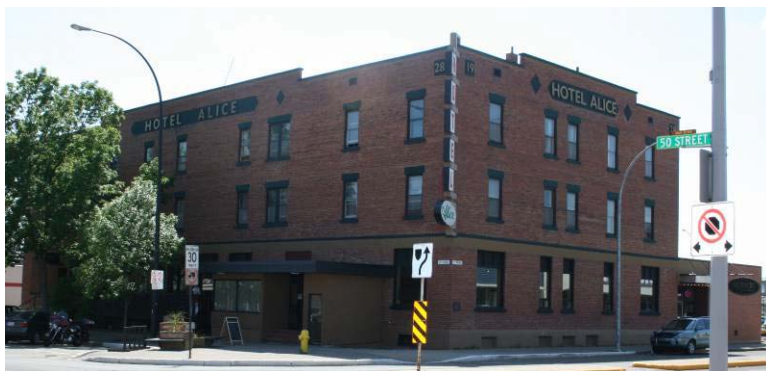
5078 50 Street**Alice Hotel**

The Alice Hotel, built in 1928, is a three storey brick building with a stepped parapet and decorative brickwork that reads “HOTEL ALICE” and its date of construction, “19” “28”. It is located on a corner lot in a commercial area on main street in the City of Camrose.

- The flat roof with stepped parapet
- The common bond brick exterior
- The decorative diamond pattern brickwork along the third storey
- The precast stone lintels and sills and exposed concrete foundation
- All authentic windows and doors, and authentic windows and door openings

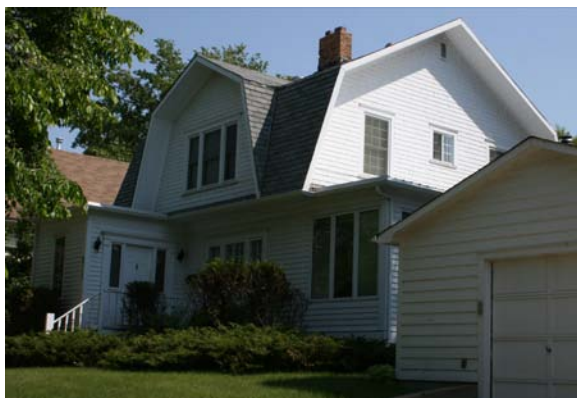
4717 51 Street**Residence**

This 1912 two storey residence has an intersecting gambrel roof with clapboard siding and an enclosed front porch. It is located on a single lot in a residential neighbourhood in Camrose.

- The intersecting gambrel roof
- The wood shingles under the gambrels
- The clapboard siding
- The brick chimney
- The enclosed front porch
- All authentic windows and doors, and all authentic window and door openings

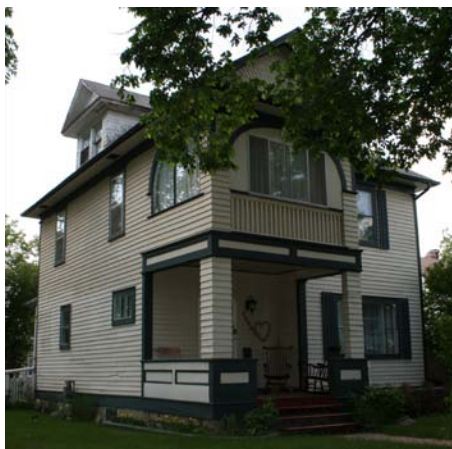
4902 52 A Street**John Russell Residence**

This 1910 two and one half storey house has a hip roof with a side-facing gable dormer and an open front porch. It is located on a single corner lot in a residential neighbourhood in the City of Camrose.

- The hip roof with side-facing gable dormer
- The clapboard siding
- The decorative shingles under the gable
- The two storey front porch with square columns
- The wood panels along the sides of the first storey porch and wooden railing along the second storey of the porch
- All authentic windows and doors, and all authentic window and door openings

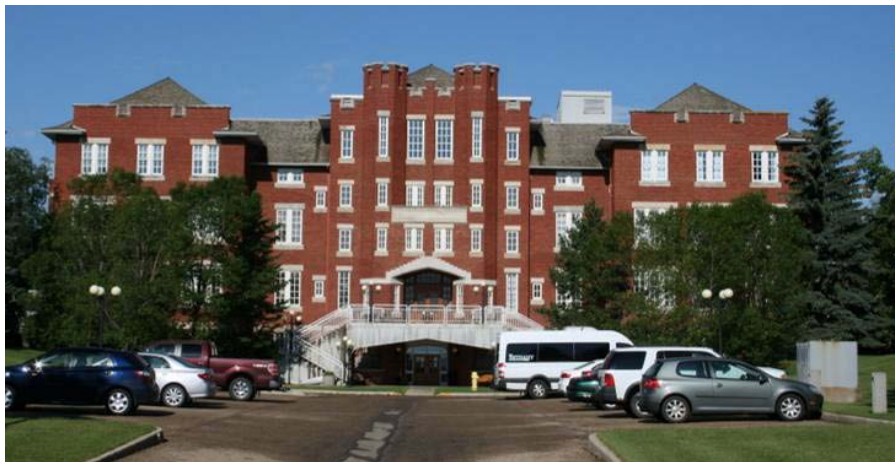
4612 53 Street**Camrose Normal School/Rosehaven**

The 1915 Camrose Normal School/Rosehaven is a three and one half storey brick building with hip roofs with front stepped parapets. It has engaged octagonal towers flanking the main entrance and an open front entrance with a gable roof and round columns. The Camrose Normal School/Rosehaven is located on its own campus in a residential area in the City of Camrose.

- The brick exterior with extensive cast stone detailing
- The fenestration pattern of solid wall and window opening
- The multiple hip roofs
- The crenulated parapets
- The octagonal four storey stairwell towers
- The square headed mullioned windows with cast stone lintels and sills

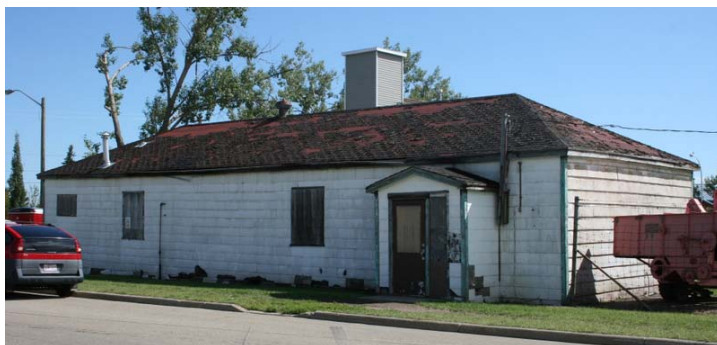
5316 49 Street**Old Army Barracks**

The circa 1940, one storey, Old Army Barracks is a rectangular building with a hip roof. It has asbestos shingle siding and an enclosed porch. It is located on the former fairgrounds property and is surrounded by a multi purpose area which includes institutional, recreational and residential developments.

- The hip roof
- The rectangular plan
- The asbestos shingle siding
- All authentic windows and doors, and all authentic window and door openings

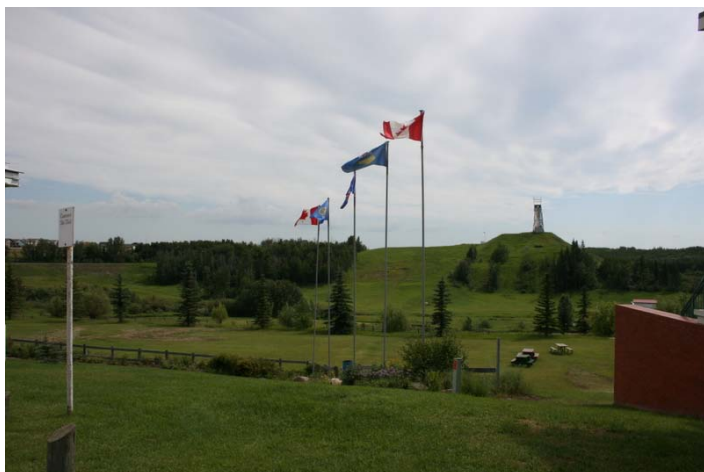
The Camrose Ski Hill is a recreational facility originally first used in 1911. It is located in a recreational area in the City of Camrose.

- Open space at the top and side of the hill
- And the levelling at the top of the hill

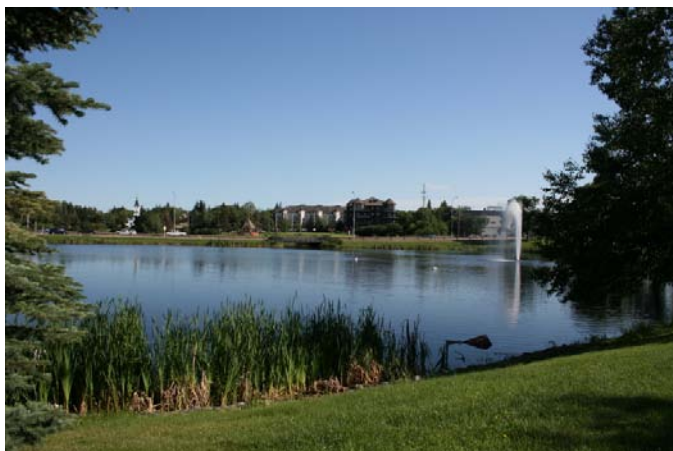
Mirror Lake is a cultural landscape comprised of an artificial lake and surrounding park area which was created in 1905 and is located along 48 Avenue and 48 A Avenue in central Camrose.

- The lake and its environs
- The location along 48 Avenue, and 48 A Avenue
- The walking trails around the lake

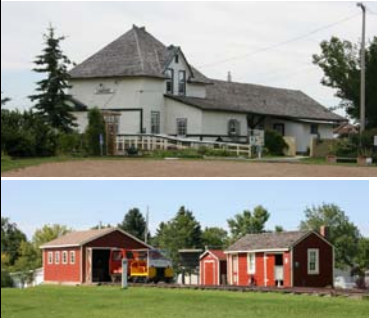
<p>One and one half storey railway station with a hip roof, gable dormers, stucco exterior, and wide eaves with large brackets. Also included on the site are the section tool shed, and watchman's shed, that are simple wood frame structures with a gable roof.</p>
Significance Criteria	A: Theme – Transportation Development in the City of Camrose C: Design – Canadian Northern Railway Plan 100-29
Context	Located on approximately ten hectares of land in the east end of the City of Camrose.
Period of Significance (POS)	1911 – present
Character Defining Elements (CDEs)	<ul style="list-style-type: none"> steeply-pitched cedar-shingled hipped roof over main station area decorative roof ridge wood cresting low-pitched, cedar-shingled gable roof over baggage area with very wide, open bracketed eaves corbelled chimney forest green and gold colouring of trim gabled wall dormers on the front and back elevations fenestration pattern and style, including nine-over-one double-hung sash units original door pattern and style, including standard five panel interior doors floor plan open layout, wall and ceiling finishes of freight room original mouldings, staircases, flooring, and fixtures original artefacts associated with the site <p>Section Tool Shed</p> <ul style="list-style-type: none"> red exterior with yellow trim door and fenestration pattern <p>Watchman's Shed</p> <ul style="list-style-type: none"> red exterior with yellow trim door and fenestration pattern

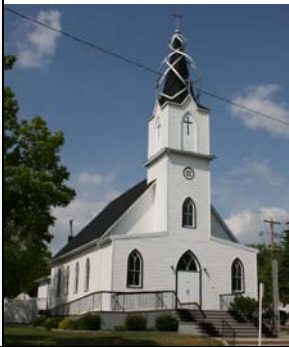
<p>Church building with clapboard siding, front-facing gable with a large intersecting tri level tower with steeple, pointed arch windows and a pointed arch entrance. Steeple is decorated with two additional metal crosses and spiral.</p>
Significance Criteria	<p>A: Theme – Religious Development of the City of Camrose E: Landmark</p>
Context	Located on a lot north of Mirror Lake in the City of Camrose.
Period of Significance (POS)	1910 – present
Character Defining Elements (CDEs)	<ul style="list-style-type: none"> • Front-facing high pitched gable roof with tri level tower and metal crosses • Round opening on the steeple • Pointed arched windows with tracery and pointed arch door openings • Three-over-two arched windows along the side and front façades <ul style="list-style-type: none"> ▪ Arched three pane transom over the double front doors
Integrity Criteria:	The overall integrity of this building is satisfactory.

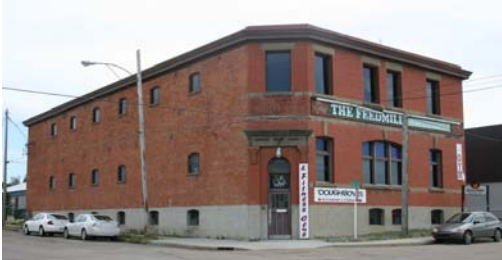
<p>Two storey commercial building with a red brick exterior, chamfered front corner enterway, and arched windows.</p>
Significance Criteria	A: Theme – Wholesale Development in the City of Camrose C: Design – Alberta Warehouse
Context	Located on a corner lot in a commercial area in the City of Camrose.
Period of Significance (POS)	1910 – 1930
Character Defining Elements (CDEs)	<ul style="list-style-type: none"> ▪ Flat roof ▪ Rectangular design ▪ Brick exterior ▪ Decorative brickwork ▪ Fenestration pattern, including segmental arched windows ▪ Stone sills, lintels, keystones and stringcourses on the front façade ▪ Chamfered front corner containing entryway composed of a doorway with round arched transom and a stone porch roof supported by corbelled brick brackets
Integrity Criteria:	The overall integrity of this building is satisfactory.

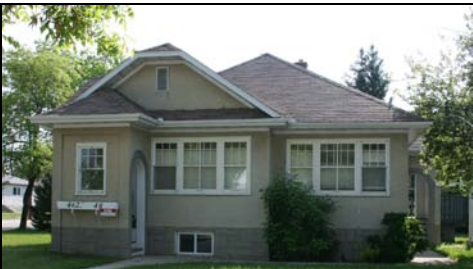
<p>One storey residence with stucco exterior, pyramid roof, and an enclosed front porch with a and a hip roof and front-facing hip gable dormer.</p>
Significance Criteria	A: Theme – Post World War I Residential Development in the City of Camrose
Context	Located on a single corner lot in a residential neighbourhood in the City of Camrose
Period of Significance (POS)	1929 – 1930
Character Defining Elements (CDEs)	<ul style="list-style-type: none"> ▪ Hip roof with front-facing hipped gable dormer ▪ Stucco exterior ▪ Enclosed front porch with the arched doorway ▪ Three-over-one double hung windows ▪ Six-over-one windows ▪ All authentic windows and doors, and all authentic window and door openings
Integrity Criteria:	The overall integrity of this building is satisfactory.

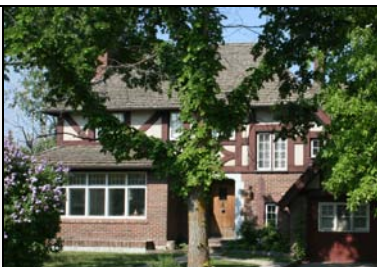
<p>Two storey residence with a brick first storey and half timbering on the second storey with a medium hip roof with a side intersecting gable.</p>
Significance Criteria	<p>A: Theme – Post World War I Residential Development in the City of Camrose</p> <p>B: Person – Frank Farley</p>
Context	Located on a single lot in a residential neighbourhood in the City of Camrose
Period of Significance (POS)	1929 – 1930
Character Defining Elements (CDEs)	<ul style="list-style-type: none"> ▪ Hip roof ▪ First storey common bond brick exterior ▪ Second storey half timbering and stucco exterior ▪ Two brick chimneys with corbelled tops, one interior chimney and one exterior chimney ▪ Recessed wooden front door with Tudor arch and precast quoin surround and lintel ▪ All authentic windows and doors, and all window and door openings
Integrity Criteria:	The overall integrity of this building is satisfactory.

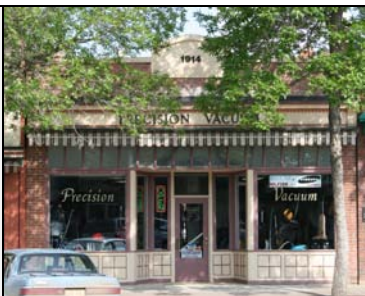
<p>One storey brick commercial building with a retail storefront and a recessed doorway, with plain bulkheads and large display windows with transoms, and an arched date stone that reads "1914."</p>
Significance Criteria	<p>A: Theme – Early Commercial Development in the City of Camrose B: Person – H.G. Johnstone</p>
Context	Located on a commercial lot on main street in the City of Camrose
Period of Significance (POS)	1914 – 1962
Character Defining Elements (CDEs)	<ul style="list-style-type: none"> ▪ Commercial storefront including the large display windows with wood build heads, the recessed entrance, the transom windows and the sign board ▪ Brick exterior ▪ Flat roof ▪ Arched date stone that reads "1914"
Integrity Criteria:	The overall integrity of this building is satisfactory.

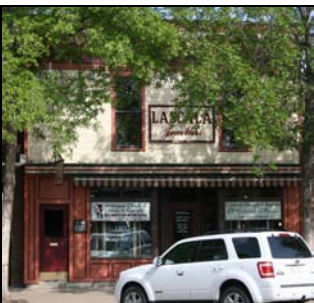
<p>Two storey commercial building with a recessed doorway, and a first and second storey cornice, with wood panelled lower storey, and faux tin concrete block design on the second storey.</p>
Significance Criteria	<p>A: Theme – Early Commercial Development in the City of Camrose B: Institution – Langbell's Studio</p>
Context	Located on a commercial lot on main street in the City of Camrose
Period of Significance (POS)	1910 – 1961
Character Defining Elements (CDEs)	<ul style="list-style-type: none"> ▪ Two decorative cornices ▪ Wood panelled lower storey ▪ Faux tin concrete block design on the second storey ▪ Recessed doorway ▪ All authentic windows and doors, and all authentic window and door openings
Integrity Criteria:	The overall integrity of this building is satisfactory.

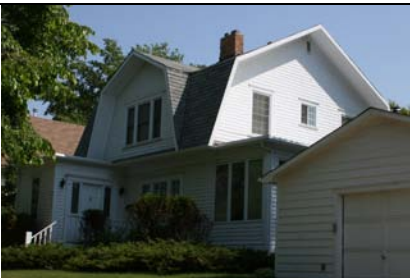
<p>Two storey intersecting gambrel roof residence with clapboard siding and an enclosed front porch.</p>
Significance Criteria	A: Theme – Early Residential Development in the City of Camrose
Context	Located on a single lot in a residential area in the City of Camrose
Period of Significance (POS)	1912 – 1920
Character Defining Elements (CDEs)	<ul style="list-style-type: none"> ▪ Intersecting gambrel roof ▪ Wood shingles under the gambrels ▪ Clapboard siding ▪ Brick chimney ▪ Enclosed front porch ▪ All authentic windows and doors, and all authentic window and door openings
Integrity Criteria:	The overall integrity of this building is satisfactory.

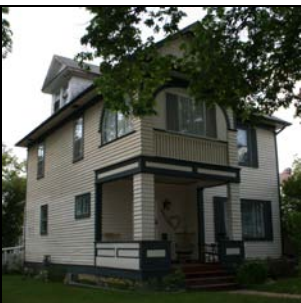
<p>Two and one half storey residence with clapboard siding, hip roof, an open front porch and side-facing gable dormer.</p>
Significance Criteria	<p>A: Theme – Early Residential Development in the City of Camrose B: Person – John Russell</p>
Context	Located on a corner lot in a residential area in the City of Camrose
Period of Significance (POS)	1910 – 1955
Character Defining Elements (CDEs)	<ul style="list-style-type: none"> ▪ Hip roof with side-facing gable dormer ▪ Clapboard siding ▪ Decorative shingles under the gable ▪ Two storey front porch with square columns ▪ Wood panels along the sides of the first storey porch and wooden railing along the second storey of the porch ▪ All authentic windows and doors, and all authentic window and door openings
Integrity Criteria:	The overall integrity of this building is satisfactory.

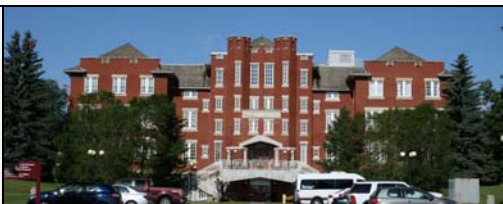
<p>Three and one half storey brick building with hip roofs with front stepped parapets, three stories of multi-paned windows.</p> <p>Engaged octagonal towers flanking the main entrance and open front entrance with a gable roofs and round columns.</p>
Significance Criteria	<p>A: Theme – Education Development in the Province of Alberta</p> <p>B: Person – Dr. C. McNally</p> <p>C: Design – Collegiate Gothic</p> <p>E: Landmark</p>
Context	Located on an entire block of park like grounds in the City of Camrose.
Period of Significance (POS)	1915 – present
Character Defining Elements (CDEs)	<ul style="list-style-type: none"> ▪ Brick exterior with extensive cast stone detailing ▪ Fenestration pattern of solid wall and window opening ▪ Multiple hip roofs ▪ Crenulated parapets ▪ Octagonal four storey stairwell towers ▪ Square headed mullioned windows with cast stone lintels and sills
Integrity Criteria:	The overall integrity of this building is satisfactory.

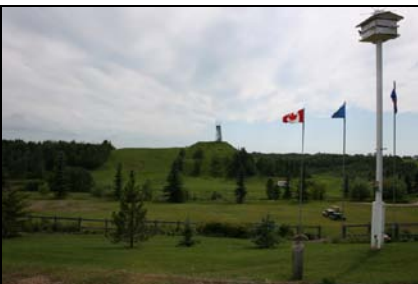
Camrose Ski Hill

<p>A natural landscape located in the City of Camrose, with a modern ski jump.</p>
Significance Criteria	A: Theme – Early Recreational Development in the City of Camrose
Context	Located in a recreational area in the City of Camrose.
Period of Significance (POS)	1911 – present
Character Defining Elements (CDEs)	<ul style="list-style-type: none"> ▪ Open space at the top and side of the hill ▪ And the levelling at the top of the hill
Integrity Criteria:	The overall integrity of this building is satisfactory.

1. Location	The location of the building has not changed.
2. Design	The design of the building has not been significantly altered.
3. Environment	The environment, or surrounding, has not changed significantly over the years.

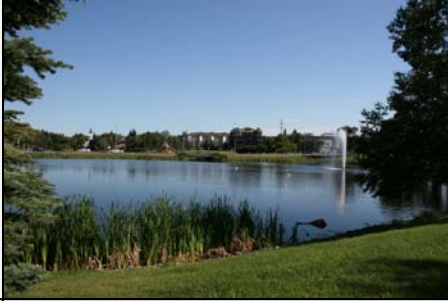
Mirror Lake

<p>An artificial lake located along 48 Avenue and 48 A Avenue in a commercial and recreational area in the City of Camrose.</p>
Significance Criteria	A: Theme – Transportation Development in the City of Camrose E: Landmark
Context	Located along 48 Avenue in the City of Camrose
Period of Significance (POS)	1905 – Present
Character Defining Elements (CDEs)	<ul style="list-style-type: none"> ▪ Lake and its environs ▪ Location along 48 Avenue, and 48 A Avenue ▪ Walking trails around the lake
Integrity Criteria:	The overall integrity of this cultural landscape is satisfactory.

1. Location	The location of the cultural landscape has not changed.
2. Design	The design of the cultural landscape has not been significantly altered.
3. Environment	The environment, or surrounding, has not changed significantly over the years.
