# Public Washroom Assessment and Study

April 2022 | Our File: 2511-001112-0 | Submitted to: City of Camrose

McElhanney Ltd.  
100, 402 – 11th Ave. S.E.  
Calgary AB T2G 0Y4

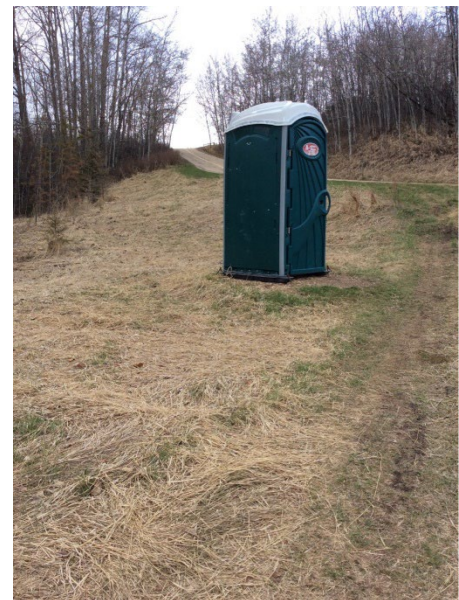
Stand-alone unit, located on top of a hill next to an asphalt pathway. This was not a permanent location and is only operational during the spring/summer. The portable is not maintained by the City of Camrose.

Portable is currently placed partway on the pathway route connecting the valley trails to the community of Creekview. The recommendation is to place portable at bottom of trail so those with limited mobility do not need to climb a steep hill to use the washroom. As well as, switch non-accessible portable with one that is accessible (i.e.: one with a ramp etc., so those using wheelchairs, walkers or having limited mobility have access to facility and can enjoy trail).

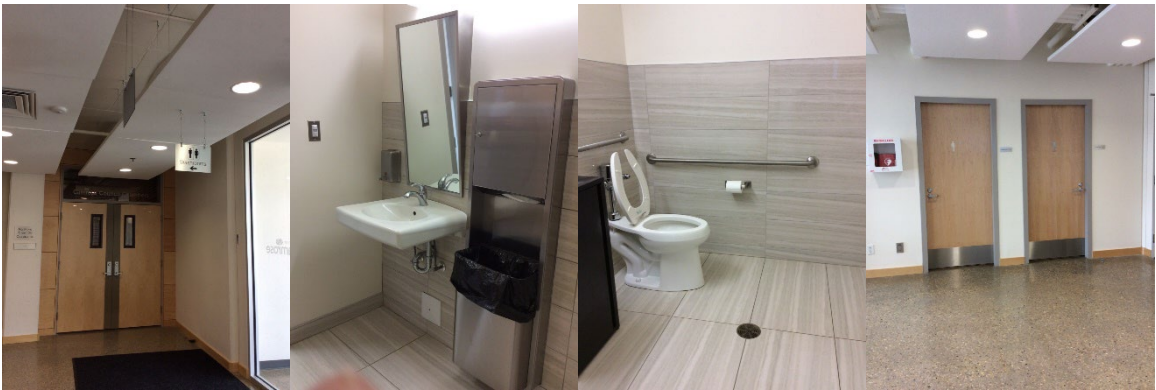
## Washroom #1 – City Hall

Washroom #1 – City Hall		
The washrooms at City Hall are located within the building – two washroom locations were noted (one upstairs and one on the main level). The facility is maintained and operated by the City of Camrose and hours are dependent of the operation of City Hall and is operational year-round.		
OBSERVATIONS	Interior	Exterior
	<p><b>Upstairs Washroom</b></p> <p>The upstairs washrooms were down the hall and around a corner. It was determined that there was not an adequate turning radius for wheelchair users to turn the corner and enter the washroom facility with ease. In addition, the men's upstairs washroom was missing its identification signage. Furthermore, there was no wayfinding signage on the upstairs floor for users. We were informed that staff are typically the only users for the upstairs washroom due to their seclusion, lack of wayfinding and access points (i.e. individuals need to travel upstairs or use the elevator). Due to the upstairs washroom being around a corner it can be noted that the washrooms themselves have limited visibility.</p> <p>Downstairs Washroom (main floor)</p>	<p>Exterior of City Hall is bright and inviting. Planting is short and does not block views. Perimeter lighting is installed, as well as up lighting. Bike racks are installed in front of facility. Door release hardware is installed.</p>

Performance Criteria		Rating
UD   Universal Design		7.0
SD   Sustainable Design		2.5
E+M   Ease and Economy of Maintenance		5.0
CPTED   Crime Prevention Through Environmental Design		6.5
UE   User Experience		8.0
Lifecycle Assessment		
Notes	City Hall is in excellent condition, and its lifespan will be 10+ years if maintenance is continued.	Expected Lifespan
		Lifespan of the facility is 10+ years.
Recommendations		
Facility Upgrades	Interior	Exterior
	Repair/install universal symbol on washroom doors.	None.
	Remove storage bins from floors and mount on the wall (c/w mounting hardware).

Washroom Facility Upgrades					
Code	Task	Meas.	QTY	Unit Price	Cost
<b>1</b>	<b>City Hall</b>				
	<b>Interior Recommendations</b>				
1.01	Repair/install universal symbol on washroom doors	ea.	2	\$ 50.00	\$ 100.00

1.02	Remove storage bins from floors and mount on the wall (c/w mounting hardware)	ea.	4	\$ 250.00	\$ 1,000.00
	<b>Subtotal</b>				<b>\$ 1,100.00</b>
<b>2</b>	<b>Library</b>				
	<b>Interior Recommendations</b>

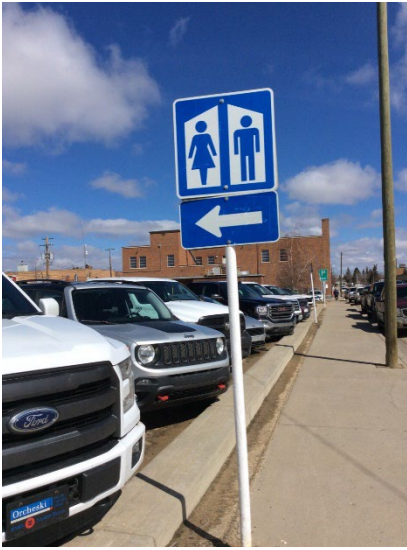
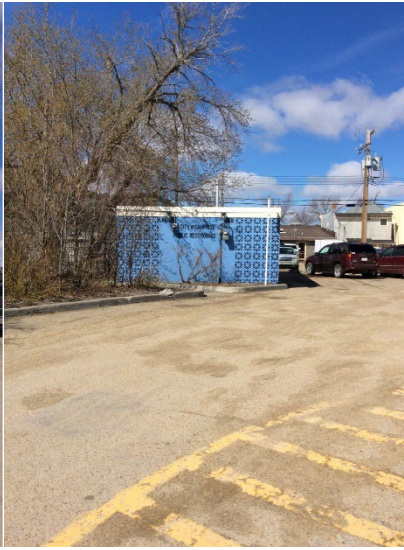
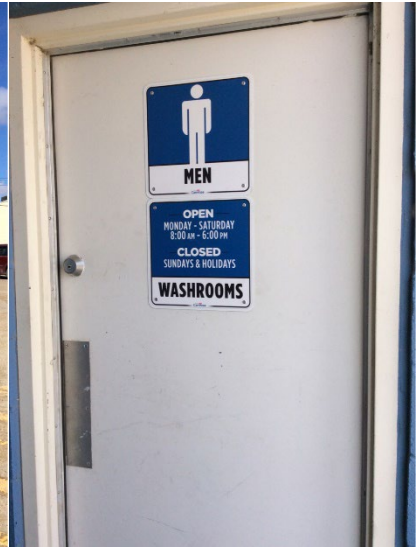
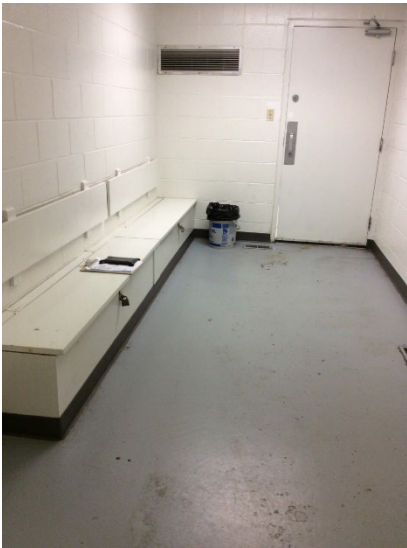
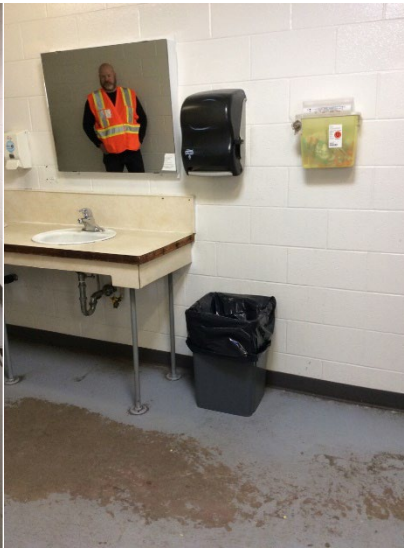
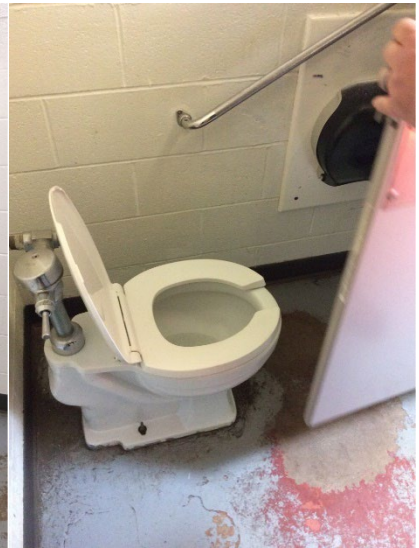
## Washroom #3 – Downtown Facility

Washroom #3 – Downtown Facility		
The downtown washroom facility houses both a men's and women's washrooms. The facility is a stand-alone building that appears to be open to the public year-round and operated by the City of Camrose.		
OBSERVATIONS	Interior	Exterior
	<ul style="list-style-type: none"> <li>Interiors of both the men's and women's washroom facilities are not inviting and are outdated – there is limited lighting, outdated fixtures, broken/vandalized furnishings, and limited visibility within the washrooms.</li> <li>Women's stalls are located around the corner in the back of the facility, ultimately limiting the ability to tell if there is anyone else occupying the washrooms.</li> <li>One skylight is installed in each of the men's and the women's washrooms, but it does not provide adequate lighting for the washrooms alone.</li> <li>Recommended that additional lighting or additional windows be installed to enhance the lighting in the facilities and that the orientation of the stall doors be changed as some of them hit the toilets while trying to open them.</li> </ul>	<ul style="list-style-type: none"> <li>Exterior of the building is constructed of concrete cinder blocks and is painted dark blue.</li> <li>Entrances are east (men's) and west (women's) facing.</li> <li>Limited visibility to women's washroom entrance as it is around the corner and in the alley.</li> <li>East side (men's) of the washroom has a sidewalk that leads visitors nowhere as it ends at corner of building – due to this, visitors are travelling along the back of the building (south side) along a dirt path to get to women's washrooms.</li> <li>South side of the building has no path, no lighting, and no visibility from the parking lot.</li> <li>Path travels along a resident's unsightly backyard.</li> <li>Two recommendations for along the south side of the building:               <ol style="list-style-type: none"> <li>1. Install fencing along back of washroom facility to block people from travelling along south side of building (preferred method) or,</li> <li>2. Install a sidewalk, with adequate lighting.</li> </ol> </li> <li>Graffiti observed on the west side of the building and it is believed that this space could be enhanced with a mural.</li> <li>Several of the exterior lights were broken or missing bulbs, and the signage for the women's side of the washroom was broken or missing.</li> </ul>

PERFORMANCE CRITERIA		RATING
UD   Universal Design		7.5
SD   Sustainable Design		2.5
E+M   Ease and Economy of Maintenance		6.0
CPTED   Crime Prevention Through Environmental Design		6.5
UE   User Experience		7.0
LIFECYCLE ASSESSMENT		
NOTES	The Downtown Facility is currently operational although outdated. There are safety issues noted through the walk-through (including limited lighting and blind corners). The women's washroom is more concerning as it is adjacent to the alley and does not appear to be well lit. It is determined that safety is the top priority and fencing, trimming and lighting should be completed first).	<b>Expected Lifespan</b>  If interior features of the washroom are updated the building itself has a lifespan of 5+ years.
RECOMMENDATIONS		
FACILITY UPGRADES	Interior	Exterior
	Install windows or additional areas for natural light to enter building (2 in women's and 2 in men's).	Install barrier or chain link fencing to deter individuals from travelling around back of building or install sidewalk and lighting to increase safety although not preferred (not included in sub-total).

Change hinges on doors to swing outward.	Replace signage on women's side of building.
		Remove graffiti on west side of building or add a mural (not included in sub-total).

3.01	Install windows or additional areas for natural light to enter building (2 in women's and 2 in men's)	ea.	4	\$ 500.00	\$ 2,000.00
3.02	Change hinges on doors to swing outward	ea.	2	\$ 250.00	\$ 500.00
	<b>Exterior Recommendations</b>

3.04	Trim all planting material along east side of building	l.s	1	\$ 750.00	\$ 750.00
3.05	Replace signage on women's side of building	ea.	1	\$ 750.00	\$ 750.00

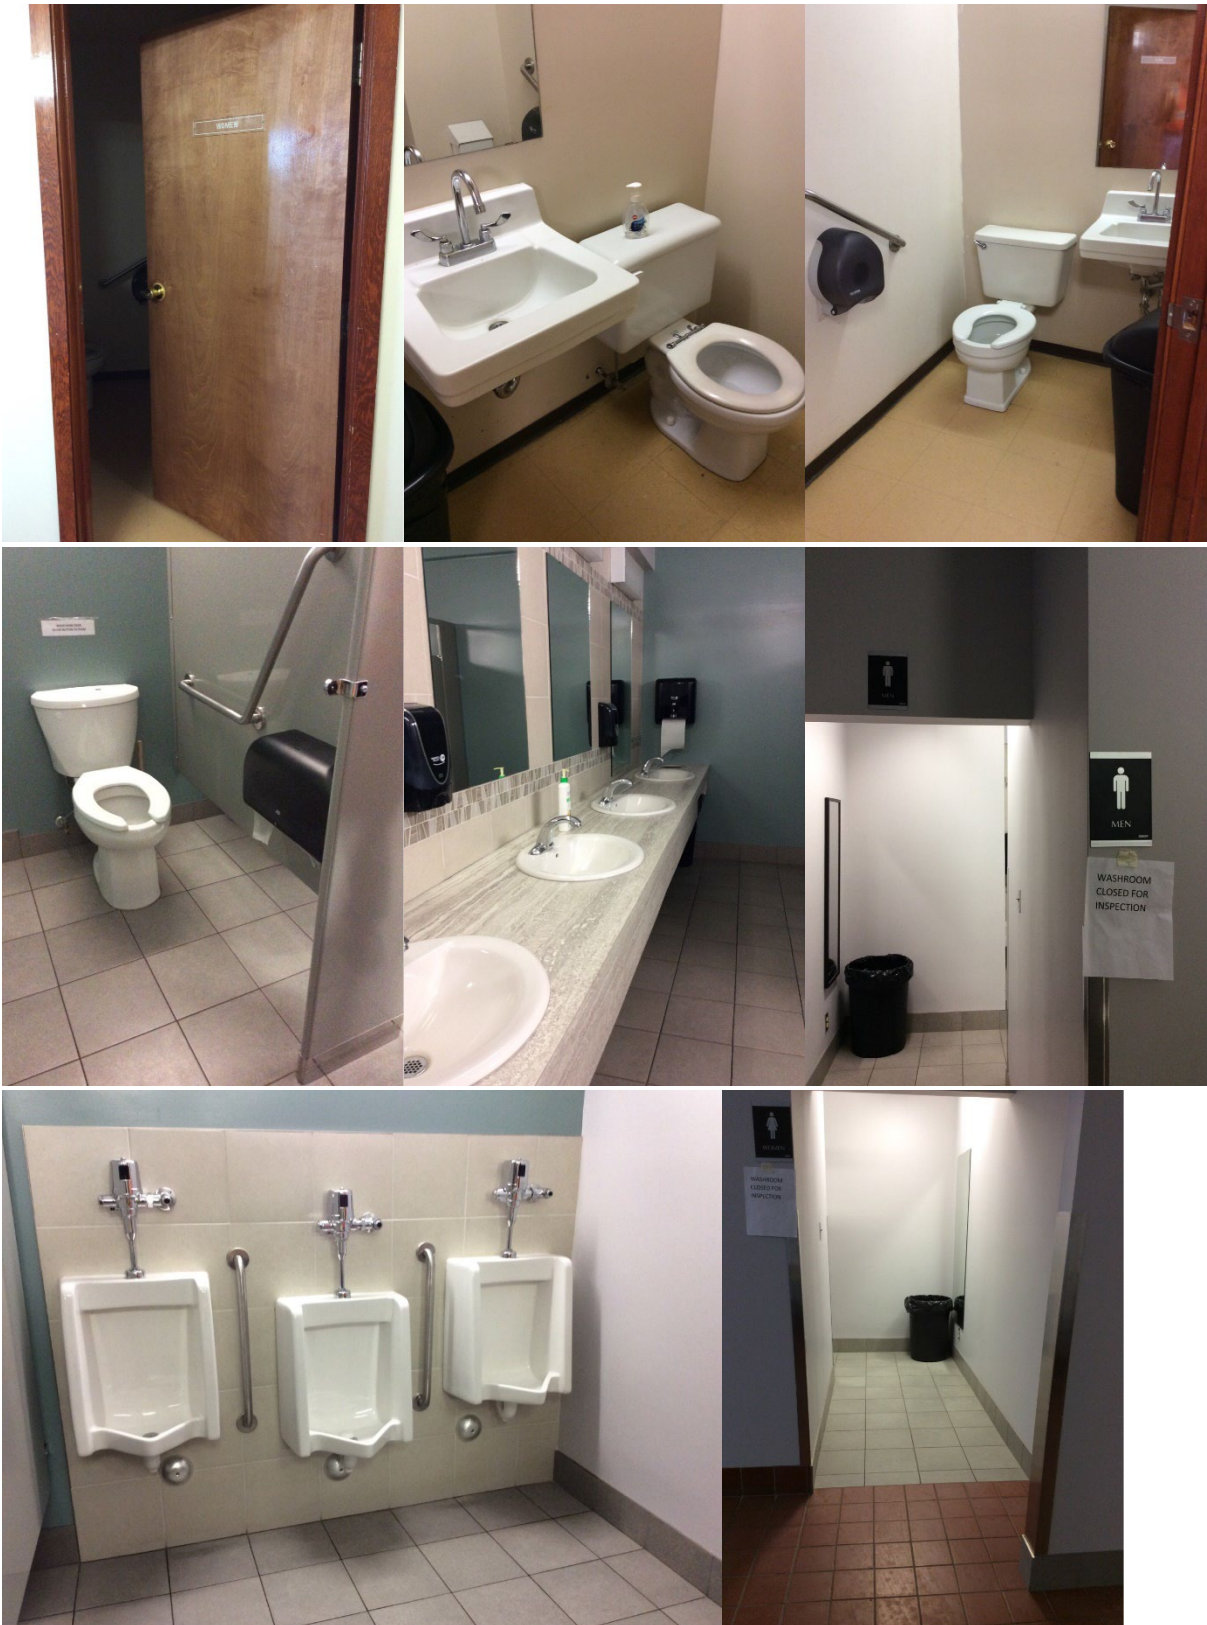
## Washroom # 17 – Mirror Lake Upstairs

Washroom # 17 – Mirror Lake Upstairs		
<p>The Mirror Lake facility is a multi-use facility providing many activities. There were two locations noted (one downstairs and two on the main level). While on site we were instructed that only 2 of the 3 sets of washrooms were open to the public. Upstairs near the front entrance are both men's and women's washroom facilities which were well maintained/updated. Located near the back of the building were single stall men's and women's washrooms; neither washrooms were up-to-date or ADA standard. The facility appears to be operated and maintained by City of Camrose and/or tenants of the building – it is open during operational hours year-round.</p>		
OBSERVATIONS	Interior	Exterior
	<ul style="list-style-type: none"> <li>• Washrooms that we assessed were located near the front entrance of Mirror Lake, and located to the right of the entrance.</li> <li>• It was documented that there was little to no wayfinding through the building; addition of wayfinding signage through building would make washrooms more accessible.</li> <li>• It was noted that washroom upkeep is an important factor; a few lights were out in the washrooms and drastically changed the amount of light.</li> <li>• Chairs placed near the accessible stalls impede the reachability to dispensers as well as maneuverability around the sink; these chairs impact the usability of the sink/accessible counter areas for those with limited mobility (using a walker, cane or wheelchair), users would be required to step or stretch/extend arm to use soap.</li> <li>• Waste receptacles in washrooms are currently located on the floor; it is recommended to install wall mounted receptacles, so they are not a trip hazard.</li> <li>• Grab bars/rails are missing from accessible stalls as well as hangers on the back of the doors to appropriate height and distances.</li> </ul>	<ul style="list-style-type: none"> <li>• Lights documented on exterior of building, do not appear to be dark sky compliant.</li> <li>• Limited visibility from parking lot to building, and there is no separation between pedestrians and vehicular traffic while travelling to building.</li> <li>• Recommended to add additional lighting as well as a safe travel lane for pedestrians to reach building entrance from parking lot.</li> </ul>

PERFORMANCE CRITERIA		RATING
UD   Universal Design		8.0
SD   Sustainable Design		5.0
E+M   Ease and Economy of Maintenance		6.0
CPTED   Crime Prevention Through Environmental Design		7.0
UE   User Experience		8.0
LIFECYCLE ASSESSMENT		
NOTES	Overall, Mirror Lake facility is generally a well maintained and updated facility, the entrance is welcoming and open. There is natural light throughout the building, and it is moderately easy to navigate. However, the parking lot is not pedestrian friendly and there is little exterior lighting – which might cause visitors to feel unsafe at night. Mirror Lake has a front washroom that appears to be the most used by visitors.	Expected Lifespan
		This washroom is in good condition and requires minimal upgrades. The lifespan of this facility is 10+ years.
RECOMMENDATIONS		
FACILITY UPGRADES	Interior	Exterior
	Remove chairs from washrooms as they impede mobility through the space.	Install dark sky compliant lighting on exterior of building (2 fixtures).

17.03	Install grab bars behind urinals and toilet in accessible stalls	l.s	2	\$ 150.00 \$ 300.00
	<b>Exterior Recommendations</b>			
17.04	Install dark sky compliant lighting on exterior of building (2 fixtures)	ea.	2	\$ 500.00 \$ 1,000.00
	<b>Subtotal</b>			<b>\$ 1,300.00</b>

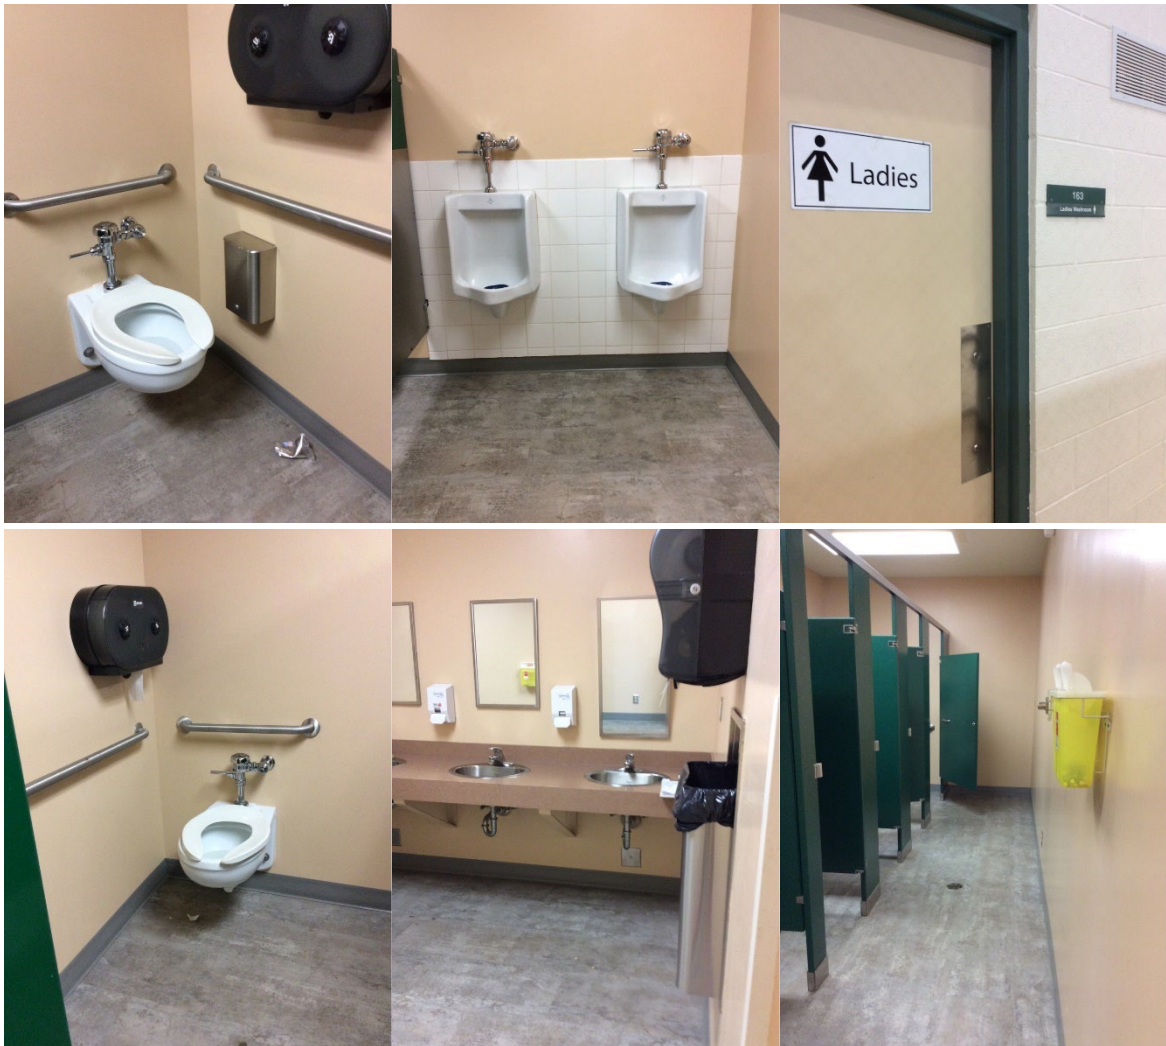
## Washroom #29 – Community Centre

Washroom #29 – Community Centre		
The Community Centre contains two washroom locations (washrooms located inside main building as well as field house). Both men's and women's washroom facilities were documented – however, no unisex/universal washrooms documented. The Community Centre is open year-round and is operated and maintained by the City of Camrose.		
OBSERVATIONS	Interior	Exterior
	<ul style="list-style-type: none"> <li>• The signage installed in the hallway to the washrooms does not indicate that it contains a universal stall and one of the signs is damaged</li> <li>• Neither of the signs are ADA compliant; it is recommended to replace signage to ADA standard as well as install signage that shows the universal symbol</li> <li>• Several items inside the washrooms need attention;               <ol style="list-style-type: none"> <li>1. the toilet paper dispenser is too high above toilet</li> <li>2. pull handles are too far away from latch on back of door in accessible stalls</li> <li>3. mirrors have been vandalized in both washrooms and should be replaced</li> <li>4. waste receptacles have been vandalized (kicked) and need to be repaired</li> <li>5. waste receptacles that are on the floor are to be removed from the washroom</li> <li>6. the paper towel dispensers are installed too high and should be relocated to appropriate height and reach from sink</li> <li>7. there is damage on walls where drywall is exposed, this needs to be patched and repainted.</li> </ol> </li> </ul>	<ul style="list-style-type: none"> <li>• There is evidence of large cracking/shifting of the sidewalk in front of the building and this had been flagged with neon pink paint</li> <li>• Threshold pieces for the doors were not a continuous piece and were made of wood, rather than metal. It is recommended that this threshold be updated and installed as a metal continuous piece</li> <li>• There is limited lighting installed in the parking lot as well as the building, and the lighting does not appear to be dark sky compliant.</li> </ul>

PERFORMANCE CRITERIA		RATING
UD   Universal Design		8.5
SD   Sustainable Design		5.0
E+M   Ease and Economy of Maintenance		5.5
CPTED   Crime Prevention Through Environmental Design		7.0
UE   User Experience		7.0
LIFECYCLE ASSESSMENT		
NOTES	The Community Centre is in good condition. ADA standard upgrades are apparent in the washrooms.	Expected Lifespan
		Without upgrades the lifespan of the facility is 5-10 years.
RECOMMENDATIONS		
FACILITY UPGRADES	Interior	Exterior
	Wall mount all waste receptacles.	Install new threshold pieces at entrance doors.
	Repair/repaint drywall.	Repair cracks in walkway.
	Reinstall paper towel dispenser to correct height (includes labour, drywall patching and relocating dispenser).	
	Install grab bars above urinals.	
	Install pull handles on back of universal doors.

<b>28</b>	<b>Rudy Swanson</b>					
	No recommendations					
<b>29</b>	<b>Community Centre</b>					
	<b>Interior Recommendations</b>					
29.01	Wall mount all waste receptacles	ea.	2	\$	500.00	\$ 1,000.00
29.02	Repair/repaint drywall	I.s	1	\$	100.00	\$ 100.00
29.03	Reinstall paper towel dispenser to correct height (includes labour, drywall patching and relocating dispenser)	I.s	1	\$	100.00	\$ 100.00
20.05	Install grab bars above urinals	ea.	2	\$	150.00	\$ 300.00
29.05	Install pull handles on back of universal doors	ea.	2	\$	25.00	\$ 50.00
	<b>Exterior Recommendations</b>					
29.06	Install new threshold pieces at entrance doors	I.s	5	\$	350.00	\$ 1,750.00
29.07	Repair cracks in walkway	I.s	1.00	\$	250.00	\$ 250.00
	<b>Subtotal</b>					<b>\$ 3,550.00</b>

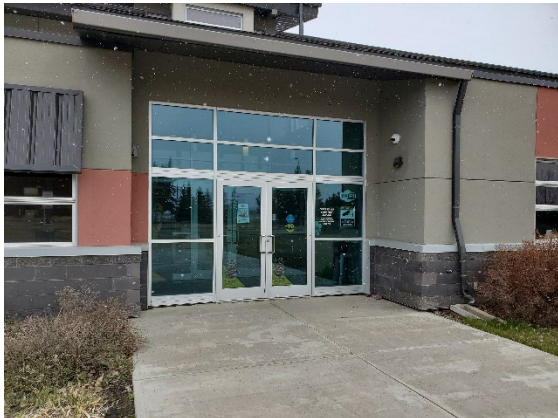
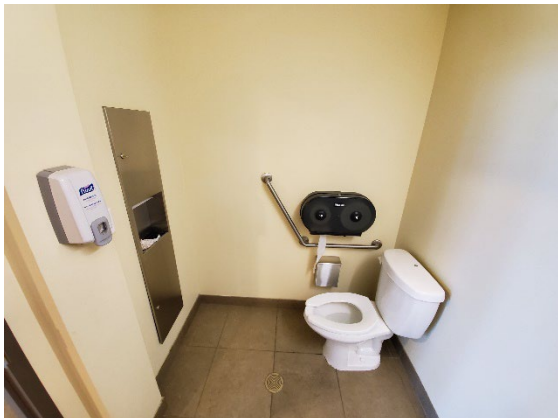
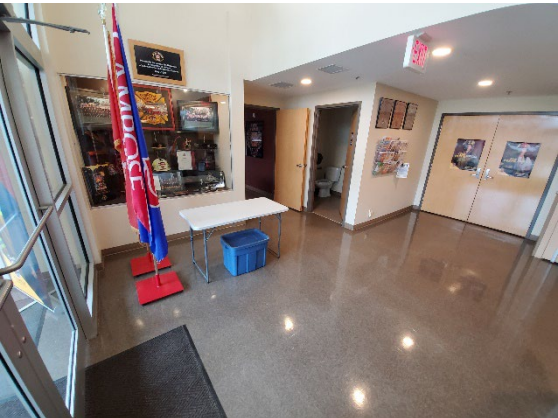
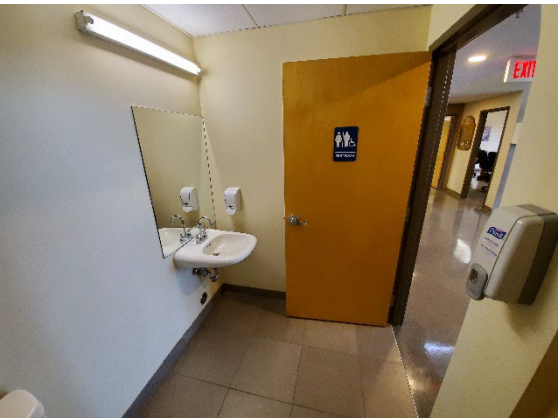
## Washroom #31 – Fire Hall

Washroom #31 – Fire Hall		
<p>Note: This assessment was completed by a City of Camrose employee. While preparing for this assessment, the team spoke to a member of the City of Camrose Fire Department to enquire about the public washroom inside the building. and was told that it was not available. The City employee went back the following day and completed the assessment. The below is completed to the best of our knowledge using site photos and a paper copy of the assessment that was used to complete the review.</p>		
OBSERVATIONS	Interior	Exterior
	<ul style="list-style-type: none"><li>• Building entrance well-lit with natural light.</li><li>• Washroom is located at the front entrance of the building so wayfinding signage is not necessary.</li><li>• The washroom is bright and in good condition.</li><li>• There is a cover missing on light in washroom and produces minimal glare off the flooring.</li><li>• Universal signage is installed on door and grab bars/ rails in stalls.</li><li>• The plant pots are located in front of the door release hardware and should be relocated to the other side of the window where they can't block hardware</li></ul>	<ul style="list-style-type: none"><li>• There is lighting installed around the building and streetlights are installed in the parking lot</li><li>• A surveillance system is located outside the door.</li><li>• There is minimal vegetation on site, and small shrubs are installed around building and do not block views to entrance.</li><li>• External door includes automated hardware installed for universal use.</li><li>• Building hours are posted at the entrance.</li></ul>

PERFORMANCE CRITERIA		RATING
UD   Universal Design		7.5
SD   Sustainable Design		5.0
E+M   Ease and Economy of Maintenance		6.0
CPTED   Crime Prevention Through Environmental Design		7.5
UE   User Experience		9.0
LIFECYCLE ASSESSMENT		
NOTES	The Fire Hall washroom is in excellent condition and requires only a few minor upgrades.	Expected Lifespan
		It is determined that the facility has a long-term lifespan of 10+ years
RECOMMENDATIONS		
FACILITY UPGRADES	Interior	Exterior
	Install shade over light to reduce glare.	
	Move stool and plants to other side of door, away from door-release hardware.

31.01	Install shade over light to reduce glare	I.s	1.00	\$ 250.00	\$ 250.00
31.02	Move stool and plants to other side of door, away from door release hardware			NA	
	<b>Subtotal</b>				<b>\$ 250.00</b>
<b>32</b>	<b>Jack Stuart School</b>				
	No recommendations				
<b>33</b>	<b>Jack Stuart School</b>				
	No recommendations				
<b>34</b>	<b>At the Trestle Bridge</b>
